## **Subsurface investigation for road construction using electrical resistivity method along Oloko road, Apatapiti, Akure, Ondo State, Nigeria**

# Subsurface Investigation for Road Construction Using Electrical Resistivity Method along Oloko road, Apatapiti, Akure, Ondo State, Nigeria

*Sodiq S. Oguntade*

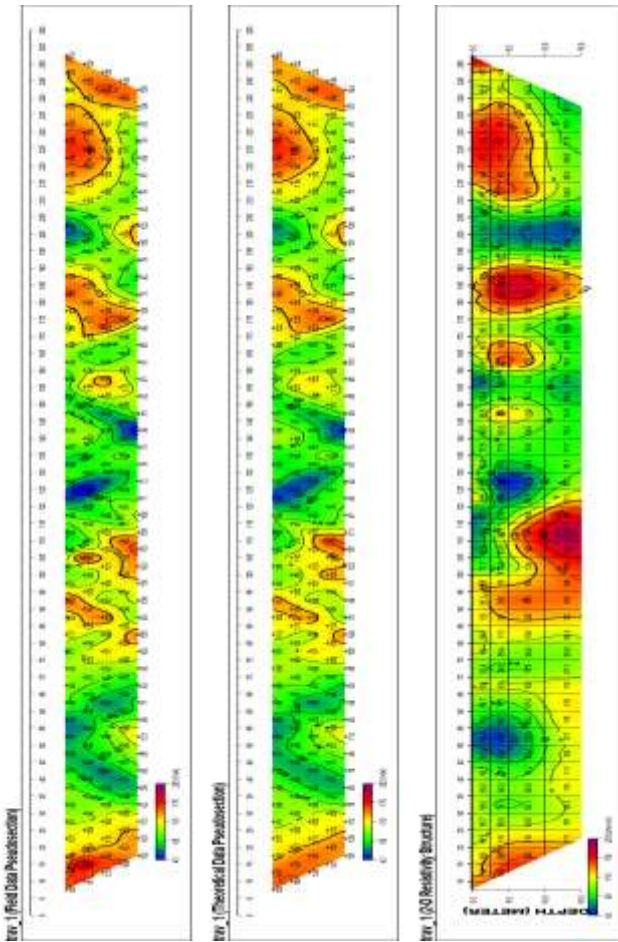
Figure 4: The inverse model resistivity section for the traverse

The 2-D resistivity structure (Figure 4) obtained from the inversed dipole-dipole data revealed three lithological layers; thin top soil (greenish-yellow and red colour), weathered layer (green and red colour) and weathered basement (green, red and purple colour). It also revealed fractured/fault as a blue colour. Due to its small thickness, the topsoil layer was frequently subsumed by the weathered layer. The profile showed predominantly low resistivity values (<100  $\Omega\text{m}$ ) at many locations at 5m depth. The lower resistivity value represented by green and yellow colour

indicates a clayey material. The overburden thickness between 100m-120m station is about 8m, and the resistivity of the basement (purple/red colour) ranges from 168  $\Omega\text{m}$  to 261  $\Omega\text{m}$ ; the shape suggests a rock boulder at the ascertained location. However, the segment is likely to fail because of the thick, low resistivity clay overburden.

Towards the southwestern part of the traverse, i.e. station, 180m-190m is resistive geology to a depth of about 10m from the surface. Station 215m-235m showed weathered strata at a depth of about 8m. In addition, indicative of linear features such as faults and fractured zones with surface expressions at distances 45-55m; 120-130m; 155-160m; and 195-205m.

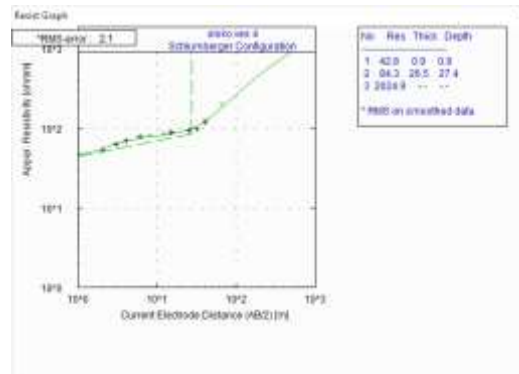
Figure 8: A Curve Type

Classification of the five sounding curves are H, A and KH. The curves are shown in Figures 5 to 9. They suggest three possibilities (Adiat et al., 2017). The first possibility is that the study area depicted a shallow depth of fresh basement (Figure 8). The second possibility is that three geoelectric layers lie beneath various parts of the study area; the second layer is the weathered basement layer. This increases the road's vulnerability because the depth to the weathered basement layer may be shallow, indicating that the layer is saturated with water (Figures 5, 7 and 8). The third possibility depicts the occurrence of a fractured basement, as shown in the third geoelectric layer (Figures 6 and 9). If not appropriately addressed during construction, the presence of a fractured basement can also jeopardise the road's stability. The summary of the geoelectric parameters at different locations is shown in table 1.

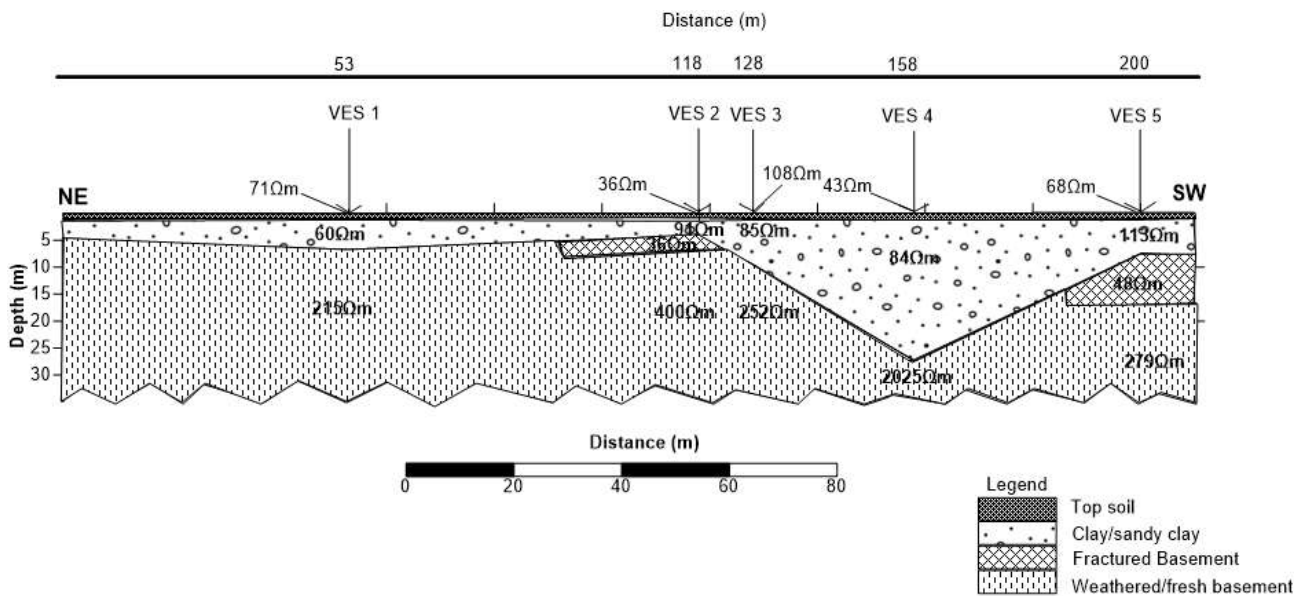
**Figure 10:** The Geoelectric section along the traverse

The geoelectric section (Figure 10), taking along the traverse, connects the study area's geoelectric sequence. Four subsurface geologic layers were delineated: the top soil, clay/sandy clay, fractured basement, weathered/fresh basement. The top soil has a resistivity that varies between 36  $\Omega\text{m}$  and 108  $\Omega\text{m}$ , and thickness ranges from 0.5m to 1.1m.

These resistivity values indicate a clayey substance. The majority of the top soil has a quite low resistivity (<100  $\Omega\text{m}$ ), indicating weak areas that could jeopardise the road's competence. The clay/sandy clay layer has a resistivity that varies from 60  $\Omega\text{m}$  to 113  $\Omega\text{m}$ , and thickness ranges from 3.8m to 26.5m. This layer is a substandard

substandard engineering material that may be detrimental to the road's stability. The fractured basement has a resistivity value that ranges from 36  $\Omega\text{m}$  to 48  $\Omega\text{m}$ , and thickness ranges from 2.5m to 9.2m. This layer constitutes weak zones and reduces the bed rock's bearing capacity. The weathered/fresh basement has a resistivity value that ranges from 215  $\Omega\text{m}$  to 2025  $\Omega\text{m}$ . The depth to the weathered/fresh basement is more than 27 m in some places in the southwestern parts of the section, while it is shallower in the Northeastern part of the section (<9 m). Characteristics of depressions observed in the southwestern section should be considered during the road structure design.

2m) must be excavated and filled with competent engineering materials before laying asphalt. The portion suspected to be underlain by linear features such as fractures/faults should be reinforced or grouted. A good drainage channel should also be constructed at the embarkment; this will prevent the accumulation of runoff on the pavement embarkment.
