Gabions: evaluation of potential as low-cost roadside barriers

Document Version:
Peer reviewed version

Giuseppina Amato[1], Fionn O'Brien[2], Bidisha Ghosh[3], Ciaran Simms[4]

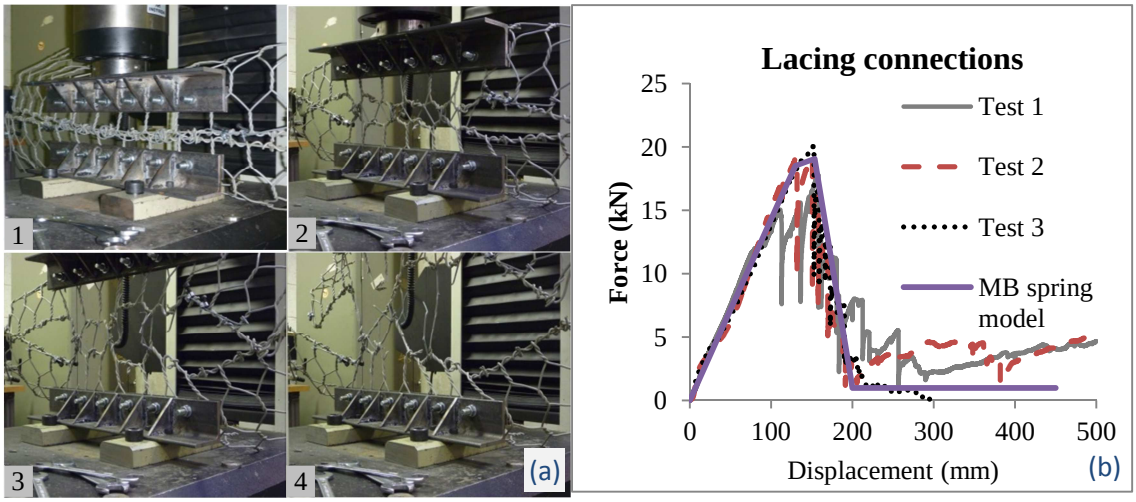
The force-displacement curves are shown in Figure 4b and in Table 1the maximum load per meter and corresponding displacement are reported. A consistent pattern in terms of slope, peak and maximum elongation was observed; failure was always preceded by a high elongation and the connections were not sensitive to individual wire failure. The experimental curves obtained were used to calibrate the MB gabion spring connections working in tension only. The force-displacement law used for the springs is plotted in Figure 4b.

Figure 4. Lacing connection test:
a) Test photos up to failure for test 1; b) Experimental force – displacement.

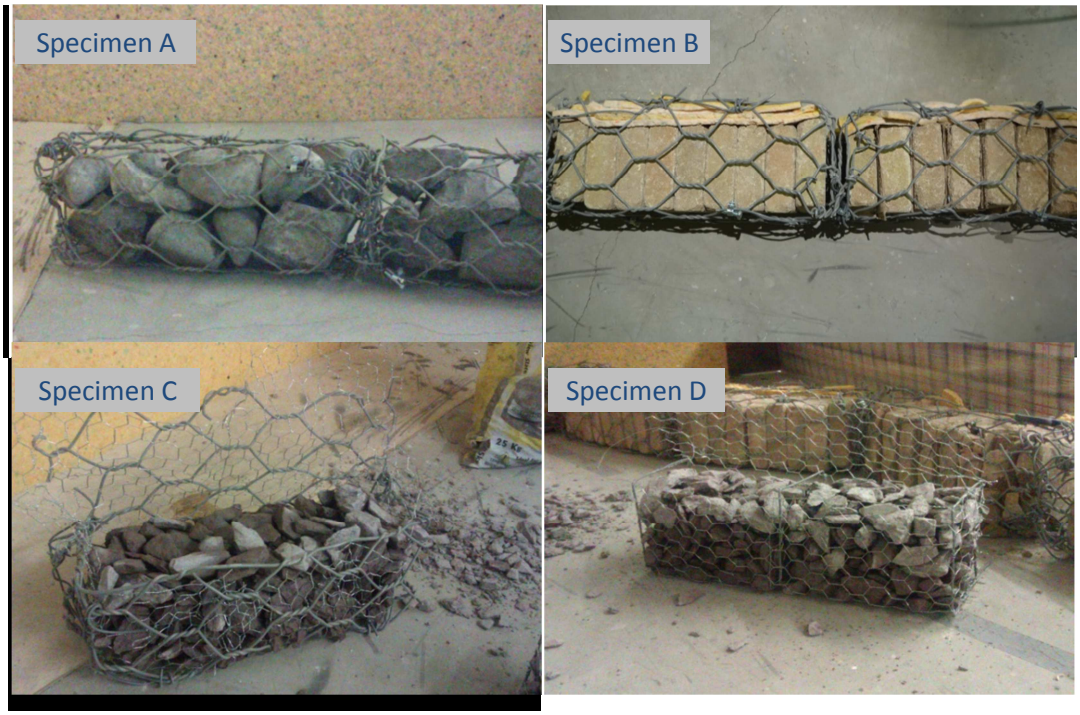
Specimens A were manufactured with full size stone and mesh. For four out of six specimens A the vehicle spun out because of the vehicle front corner being caught by the gabion mesh or a stone sticking out of it. The high speed videos showed the stone filling being pushed longitudinally along the gabion unit until constrained by the mesh. This effect was particularly enhanced by the high void ratio and by the stone and the mesh size which were large in relation to the vehicle. None of the tests failed due to snagging at the laced joints.

For both Specimens C and D small stones were used to decrease the void ratio and avoid a single stone stopping the vehicle as in tests A. In spite of this these gabion specimens were too deformable and unable to redirect the vehicle. In all the C and D tests, see Figure 11, the vehicle spun out and in some cases the deformed gabion worked as a ramp for the vehicle. The mesh was torn during the impact in tests D.

Figure 9. Gabion specimen types A-B-C-D.

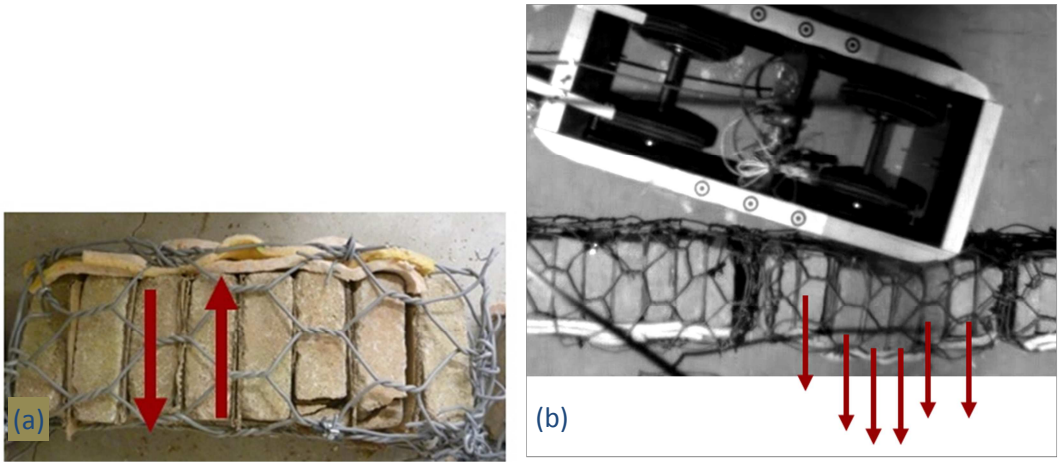
Specimens B were manufactured with cobblestone bricks, had a low void ratio and a more regular barrier surface. The vehicle was successfully redirected in five out of seven tests. For the two tests in which the vehicle spun out, the vehicle was trapped by the mesh due to an indent on the timber profile caused by a previous test. The high speed videos of the successful tests showed an almost pure shear deformation of the gabions with the bricks sliding one over the other in direction perpendicular to the barrier during the impact, see Figure 10.

Figure 10. (a) Gabion specimen type B. (b) Interaction with the scaled vehicle.

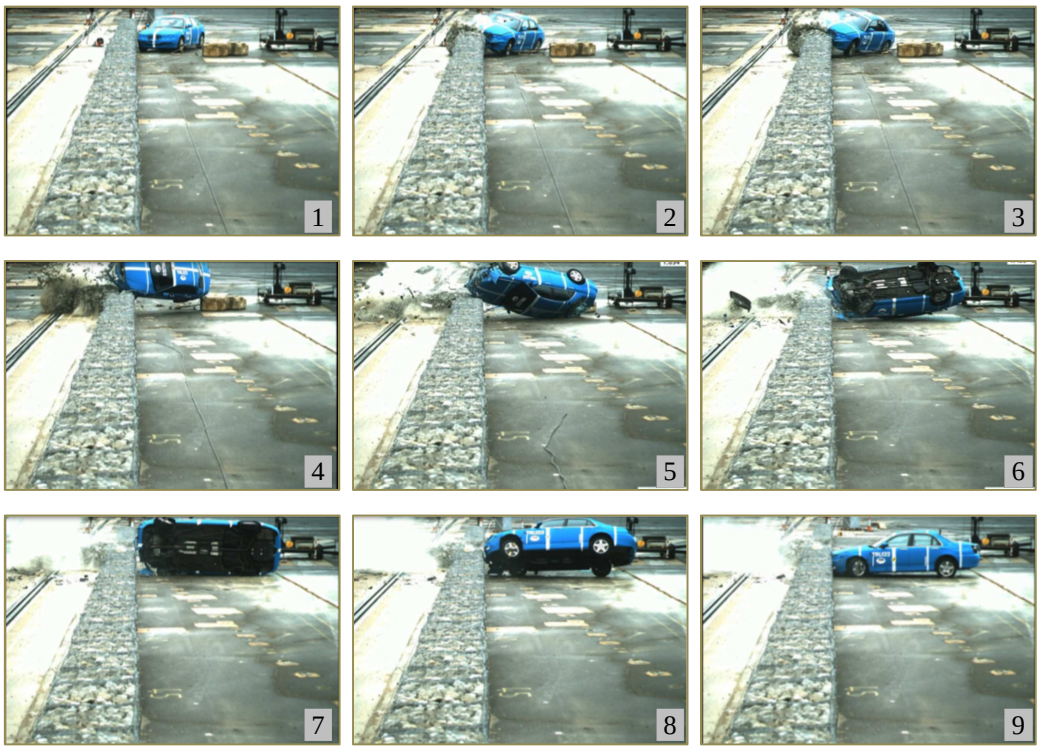
The crash test resulted in a failure due to rollover of the vehicle and excess of working width. Gabions 18 to 20, see Figure 13a, were completely opened by the impact. Gabions 21-23 were displaced rearwards. Maximum displacement of gabions was 3.4 m from the rear face of the system, see Figure 13b.

- The vehicle impacted the gabion and partially pocketed into it.
- The crushed front of the vehicle tore the mesh on the front face of the barrier.

- The pocketing and the following breaking of the mesh and deformation of the gabions caused the front of the vehicle to lift up and ramp on the barrier.

The mesh on the back of the gabions and the connections between the units did not fail and were able to contain the vehicle inside the exit box. However, the containment occurred with a mechanism of rollover for the vehicle.

The two main issues shown by the full scale test are a low strength of the mesh which was torn by the crushed front of the vehicle and a low barrier stiffness which did not redirect the vehicle. Connections on the gabion back face would have probably

Figure 12 TB31 crash test: Sequence showing the impact and roll over of the vehicle.

A high barrier contact stiffness, a low gabion void ratio (between 30% and 35%) and a stronger mesh could reduce the probability of this failure occurring. However, these are not trivial changes and it is unlikely that minor design changes would significantly alter the overall barrier behaviour. A comparison between a standard w-beam barrier manufactured with AASHTO M180 steel and cross-sectional area of about 1270 mm^2 shows an axial strength about 20 times higher than that of the mesh used for the gabion design (mesh section: length 0.75 m, opening dimension 80x100, wire diameter of 2.7 mm). Although this axial strength is only partially used during an impact, the comparison shows that enhancing the gabion front face strength and stiffness would require significant changes which would increase costs and appearance considerably.

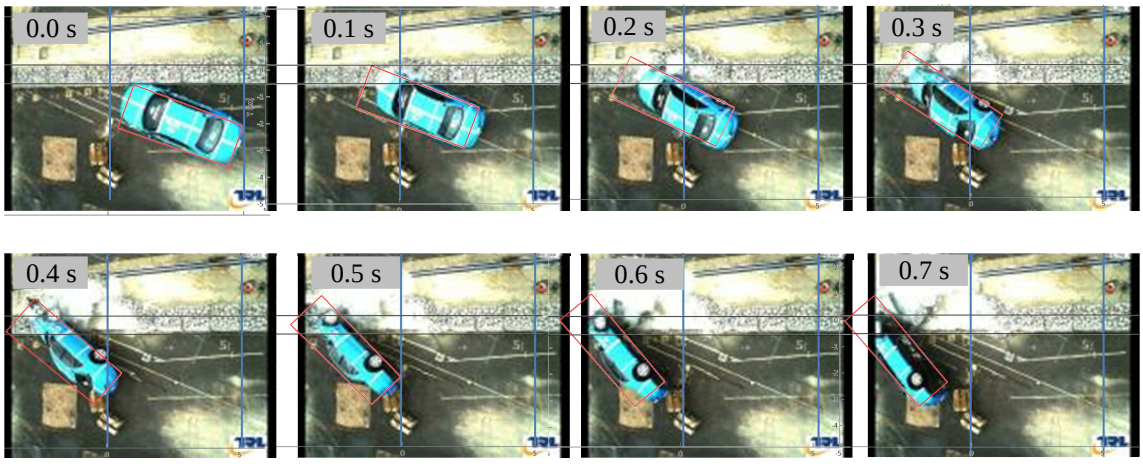
time histories; In Figure 16 the vehicle MB positions at time steps of 0.1 s are plotted on top of the high-speed video camera still shots. From the comparison of the vertical vehicle acceleration it can be seen that the model was not able to capture the vertical motion of the car while the longitudinal trajectory was correctly captured.

Figure 16. TB31 crash test: Sequence showing the impact with superimposed vehicle position from MB simulation.
