## **Subsurface investigation for road construction using electrical resistivity method along Oloko road, Apatapiti, Akure, Ondo State, Nigeria**

# Subsurface Investigation for Road Construction Using Electrical Resistivity Method along Oloko road, Apatapiti, Akure, Ondo State, Nigeria

*Sodiq S. Oguntade*

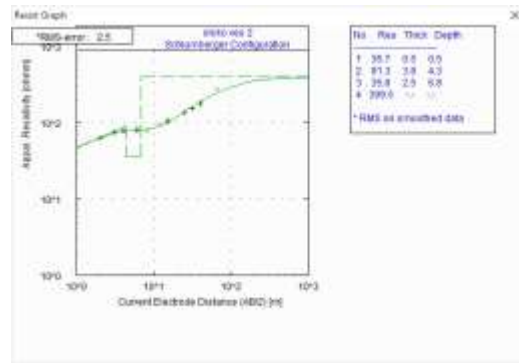
Figure 6: KH Curve Type

Classification of the five sounding curves are H, A and KH. The curves are shown in Figures 5 to 9. They suggest three possibilities (Adiat et al., 2017). The first possibility is that the study area depicted a shallow depth of fresh basement (Figure 8). The second possibility is that three geoelectric layers lie beneath various parts of the study area; the second layer is the weathered basement layer. This increases the road's vulnerability because the depth to the weathered basement layer may be shallow, indicating that the layer is saturated with water (Figures 5, 7 and 8). The third possibility depicts the occurrence of a fractured basement, as shown in the third geoelectric layer (Figures 6 and 9). If not appropriately addressed during construction, the presence of a fractured basement can also jeopardise the road's stability. The summary of the geoelectric parameters at different locations is shown in table 1.
