McConnell, E., McPolin, D., & Taylor, S. (2014). Post-tensioning of glulam timber with steel tendons. *Construction and Building Materials*, *73*, 426-433. https://doi.org/10.1016/j.conbuildmat.2014.09.079

Post-tensioning of Glulam Timber with Steel Tendons

This paper describes a series of four-point bending tests that were conducted, under service loads and to failure, on unreinforced, reinforced and post-tensioned glulam timber beams, where the reinforcing tendon used was 12mm diameter toughened steel bar. The research was designed to evaluate the benefits offered by including an active reinforcement in contrast to the passive reinforcement typically used within timber strengthening works, in addition to establishing the effect that bonding the reinforcing tendon has on the materials performance. The laboratory investigations established that the flexural strength and stiffness increased for both the reinforced and post-tensioned timbers compared to the unreinforced beams. The flexural strength of the reinforced timber increased by 29.4%, while the stiffness increased by 28.1%. Timber that was post-tensioned with an unbonded steel tendon showed a flexural strength increases in

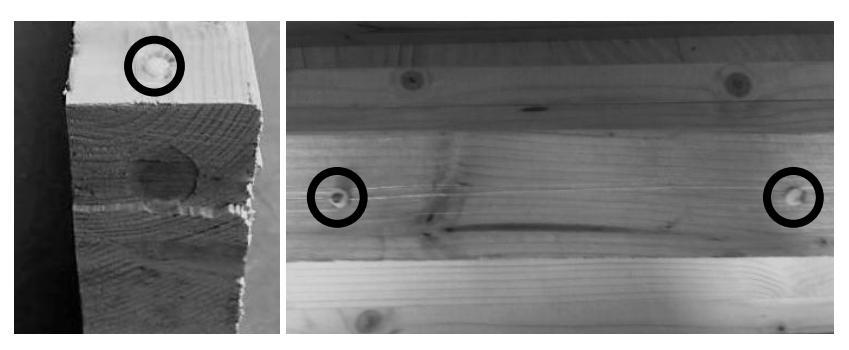
Figure 1, below, illustrates results of the preliminary testing that was conducted to ensure a sufficient bond between the steel tendon and the timber would be achieved. Epoxy adhesive was injected through pre-drilled holes in the soffit to members that were both passively and actively reinforced following elastic testing. As is evident the preliminary testing offered positive results, with a uniform 2mm bond-line being achieved around the tendon.

Fig. 1 Results of adhesive testing to ensure sufficient bond is achieved

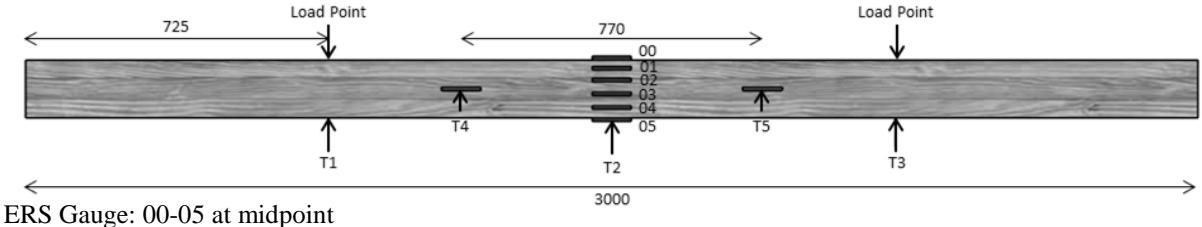
LVDT : T1-T5

The glulam timber beams were tested using the four point bending method in accordance to BS EN 408:2010[8], with the experimental arrangement as shown in Figure2. Beams were supported on roller supports, as was the spreader bar below the loading point. Lateral supports were provided to resist any lateral torsional effects that may have occurred. The timber was air dried and stored in a constant laboratory environment to ensure that the moisture content of every specimen ranged from 9-11%.

Fig. 2 Test instrumentation and arrangement

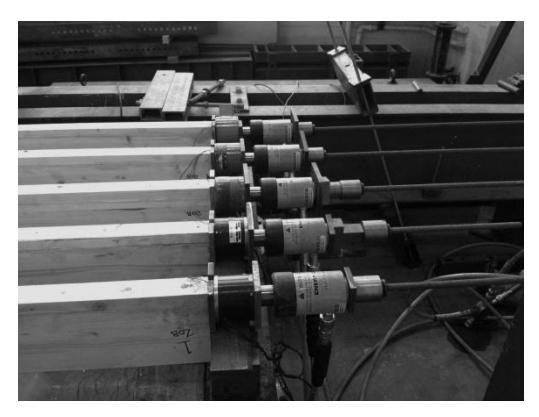
Fig. 3a Typical post-tensioning arrangement of B Series beams

The post-tensioned beams where initially tested as above, prior to the application of the tension force. Once complete the steel tendon was tensioned using a 13 ton hollow plunger cylindrical ram, located at one end of the beam. The ram was secured using open grip barrel and wedge clamps, with a load cell and bearing plates located against the timber, typical arrangement shown in Figures 3a&b. The tensile force was applied in increments, with deflection, strain and force data gathered at each interval. Once the tensile force was recorded at 20kN, elastic loading followed by loading to failure occurred as detailed previously.

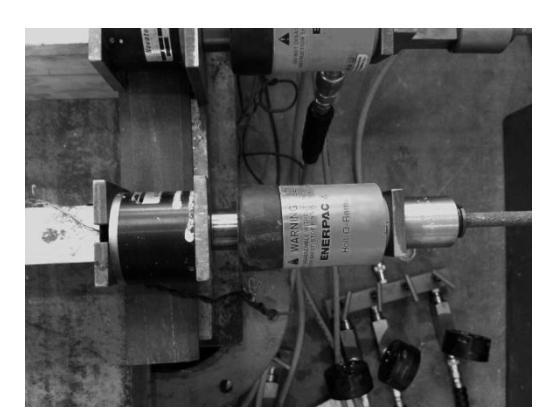
Fig. 3b Application and monitoring of post-tension force

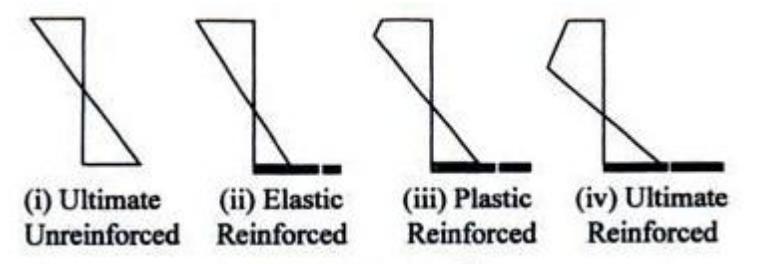
Fig. 4 Stress profiles of unreinforced and tension reinforced glulam timber^[3]

The theoretical approach used throughout this research was two-fold, initially considering the plastic failure of a reinforced glulam timber beam and additionally considering the load required to neutralise the induced stresses resulting from the post-tensioning process. Figure 4 illustrates the stress profiles for both an unreinforced and reinforced timber beam at failure. Throughout this research profile (i) and (iv) were used to calculate the ultimate capacity of the various glulam timber beams.

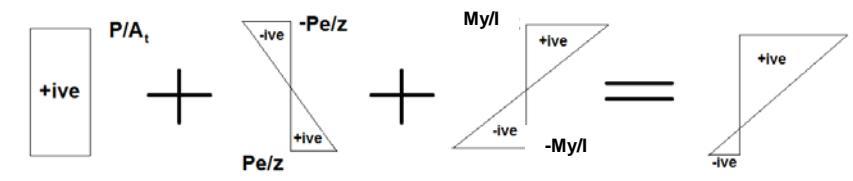
The post-tensioned glulam timber was considered as a reinforced beam, but with additional stresses that the process induces, as illustrated by Figure 5. Equation 1 and 2 demonstrate the theoretical approach taken, with the applied moment being calculated as that required to create a zero stress scenario. The calculations assumed that the post-tensioning force was fully and uniformly transferred from the steel tendon to the glulam timber, in addition to both the timber and steel behaving elastically until failure.

Fig. 5 Stress profiles from post-tensioning and load application

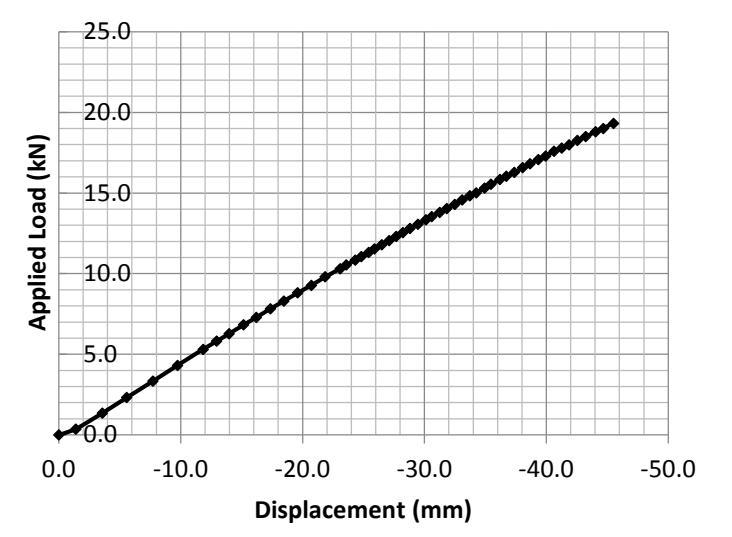
Fig. 6 Typical load/deflection graph for an unreinforced glulam timber beam

Figure 6 represents the typical deflection response of an unreinforced timber beam used throughout the experimental programme. As is evident from the figure the typically proportional trend line continues until the failure of the beam indicating that the failure mode was sudden and brittle, as was witnessed throughout the testing.

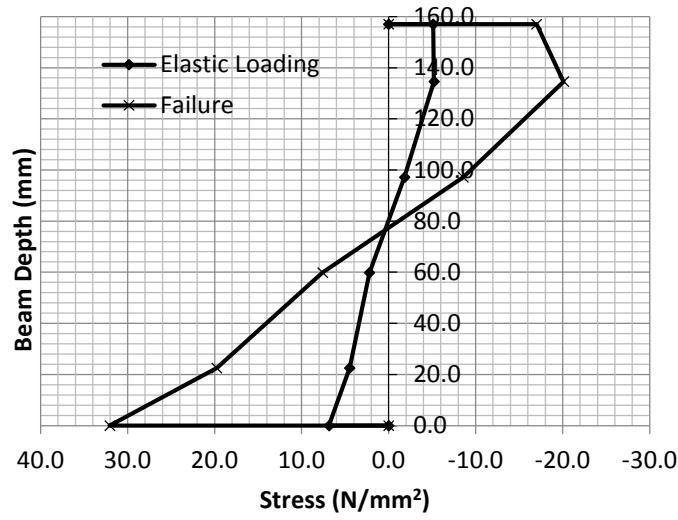
Figure 7 illustrates the average stress profiles gathered at the elastic loading limit and at failure by the strain gauges placed along the face of the timber. The elastic profile is linear, as expected, with the stress values remaining in an acceptable range. The failure profile demonstrates the plastic stress profile discussed by Patrick[3] with the peak compressive occurring below the top surface of the glulam timber. Considering the figures recorded, the peak value was reached on the soffit of the beam and accordingly all timbers in this series failed due to a tensile split along the soffit of the beam – as is expected from unreinforced timber. This plastic profile will be used for further theoretical investigations into the plastic behaviour of the glulam timber.

Fig. 7 Typical stress profile for an unreinforced glulam timber during elastic loading and failure

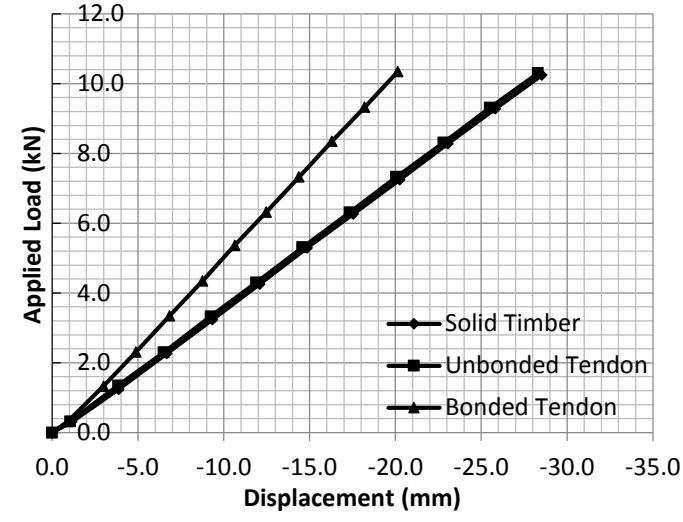
Timbers with a bonded 12mm diameter steel reinforcing tendon were tested, as detailed previously, to provide a comparison between active and passive reinforcement. Figure 8 graphically illustrates the benefits offered by the passively reinforced sections compared to the solid glulam timber. The load-deflection lines, recorded under elastic loading, show the increase in stiffness that is achieved by the inclusion of the steel tendon. A reduction of 8.2mm in service deflection is evident, equating to 28% increase in stiffness. With an average ultimate capacity of 25.8kN, an increase of approximately 30%, the advantages offered by the inclusion of passive reinforcement are clear.

Fig. 8 Typical load/deflection response of a reinforced glulam timber beam

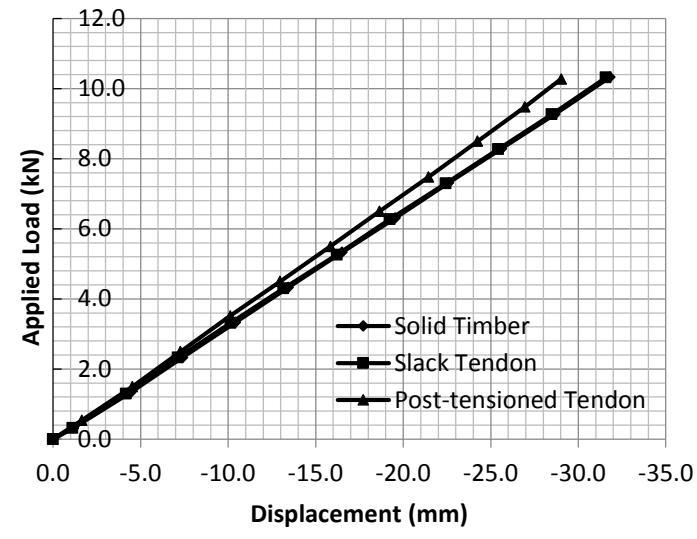
Figure 9 illustrates the additional stiffness benefit the post-tensioning process offers, by comparing the elastic response of the various states of a single beam. With the further benefit of the induced precamber ignored a stiffness increase of 8% can be seen on average. This may indicate that the lack of bonding between the tendon and the glulam timber has adversely affected the transference of the post-tensioning force. An incomplete transference of the induced stresses may account for the reduction in flexural strength and stiffness in comparison to the reinforced series.

Fig. 9 Typical load/deflection response of a post-tensioned, unbonded, glulam timber beam

From both Figure 9 and Table 5 the advantages afforded by post-tensioning an unbonded steel tendon are evident, with a benefit in both stiffness and flexural strength being observed when compared to an unreinforced glulam timber. Conversely when compared to the passively reinforced experimental data the unbonded post-tensioned timbers preform less effectively with both the stiffness and ultimate capacity being lower.

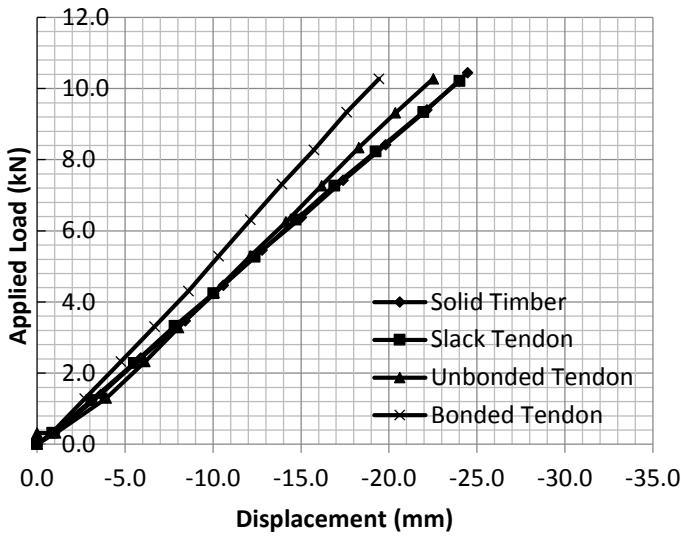
Figure 10 shows a typical load, deflection response of a beam at various stages of construction, under service loading. It is initially evident that with the application of post-tensioning, both with the tendon bonded and unbonded, there is an increase in stiffness, particularly evident under the 10kN applied load. From the figure it can be seen that there is approximately a 7.5mm reduction, approximately 28%, in service deflection between the solid timber beam and the posttensioned beam with the steel tendon bonded in place at a10kN applied load.

As is evident from Figure 10 the simple act of inserting the steel tendon through the 3m long beam has little to no effect on the overall stiffness of the member. Although the steel has a considerably higher elastic modulus the tendon alone is not sufficiently stiff over this length to result in a noticeable difference during this testing phase. This then indicates that the increase of stiffness and the resulting advantages, seen throughout these experiments, can be attributed to the posttensioning process. The graph represents the typical deflection response of the beams under service loading with the precamber induced by the post-tensioning ignored, meaning that there are further benefits offered by the post-tensioning process that aren't initially evident from the figure.

Fig. 10 Typical load/deflection response of a post-tensioned, bonded, glulam timber beam with the precamber ignored

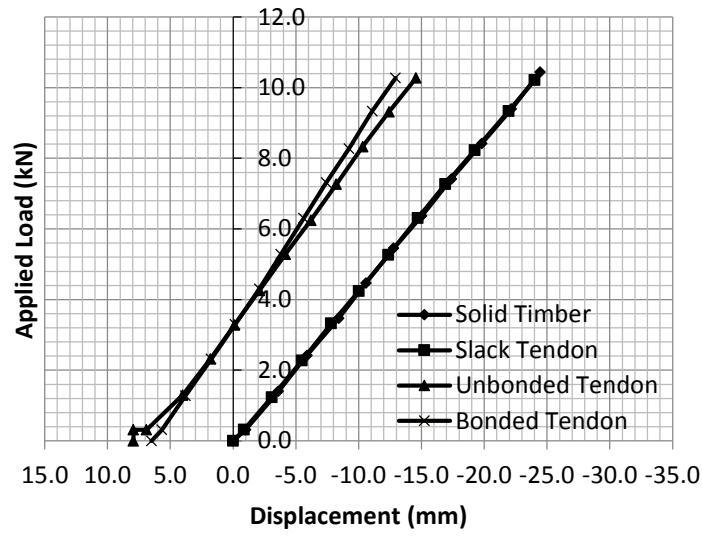
Figure 11 represents the typical deflection response under elastic loading of the same beam represented in Figure 10, but with the induced precamber considered. It is immediately evident that the 8mm precamber combined with the increased stiffness of the composite member greatly reduced the net deflection, with a reduction of 55% being realised in this average case.

Fig. 11 Typical load/deflection response of a post-tensioned, bonded, glulam timber beam

As is evident from the figure the process of post-tensioning actively reduces the tensile stresses experienced during loading. Timber primarily fails in flexure due to the tensile stresses exceeding the tensile strength of the material, which is weakened through the presence of knots and other defects. A 55% reduction in the stress value on the soffit of the timber is evident when the solid timber specimen is compared to the post-tensioned composite under the service loading. This figure provides a basic explanation of how the addition of post-tensioning strengthens the timber.

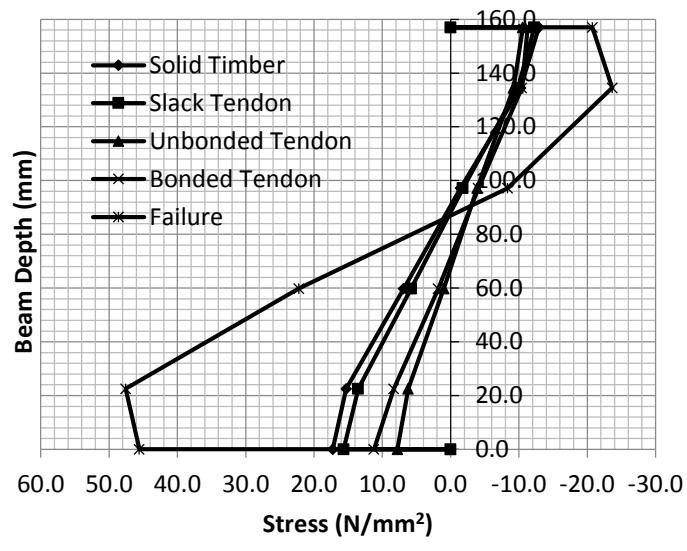
The stress profile shown in Figure 12 is comparable to that shown in Figure 8. The typical plastic profile of the glulam timber is still evident, but with the addition of a stress peak at the location of the post-tensioning tendon. The timbers experimentally tested all failed compressively, with splitting occurring on or below the top surface of the beams. Considering Figure 12 in relation to this, the failure mode may not be initially evident, as considerably higher stresses are recorded near the soffit of the member. The observations and recorded data lead to the conclusion that the post-tensioning of the timber overcomes any natural defects that the material may have, such as knots and fissures. By effectively holding these defects together, the tensile strength of the material is considerably increased, causing an overall increase in flexural strength.

Fig. 12 Typical stress profile for a post-tensioned, bonded, glulam timber during elastic loading and failure

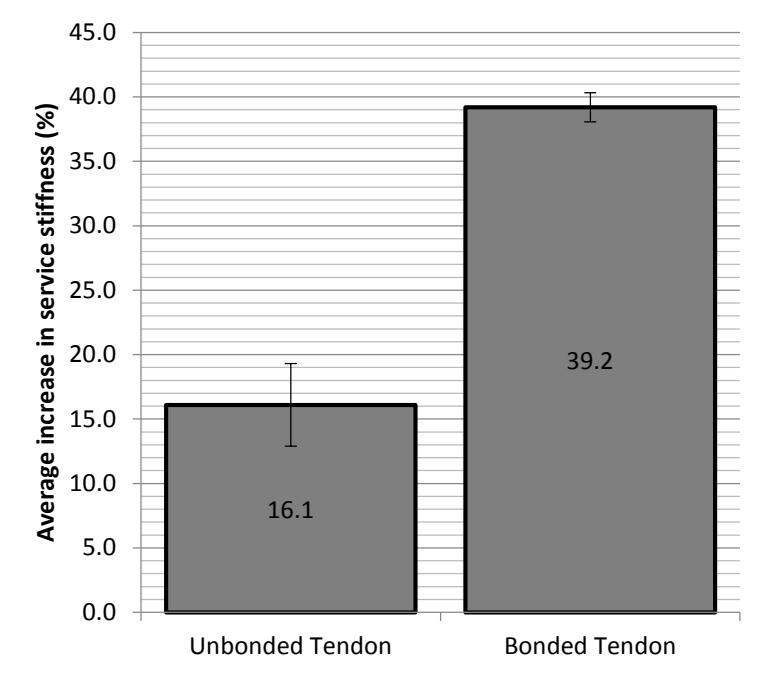
Fig. 13 Average percentage increase in service stiffness of unbonded and bonded post-tensioned glulam timber

Table 5 and Figure 13 illustrate the increase in stiffness, at service level, that the experimental research observed during the process of post-tensioning and bonded the glulam timbers. As timber is a highly variable material it is not accurate to compare results of differing members to one another. By separating the post-tensioning method into various stages and testing each elastically direct comparisons may be drawn, allowing

Table 5 shows the increase in the timbers modulus of elasticity at each stage, calculated as explained in Equation 3. As expected slotting the slack steel tendon through the length of the member does not improve the stiffness. This section of the research was included to prove that the inclusion of the steel tendon does not cause any improvement to the performance of the timber. Considering the post-tensioned process both the unbonded and bonded service results show an increase in the member's stiffness.

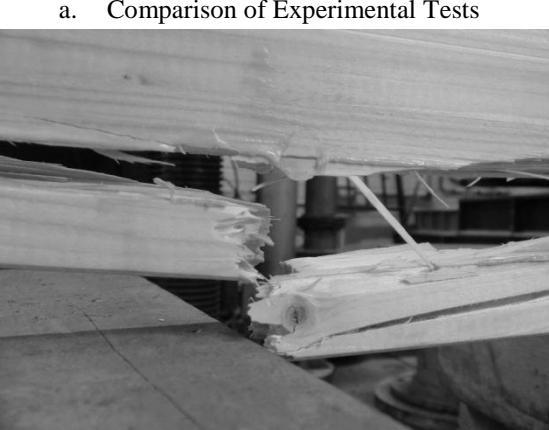
Fig. 14a Typical tensile failure of unreinforced glulam timber

Figure 14 a&b above illustrate the typical failure modes observed throughout the experimental testing. Figure 14a represents the tensile failure that occurred for the unreinforced glulam timber. As previously discussed this is to be expected as the inherent defects contained within the timber cause weaknesses susceptible to tensile stresses, meaning that all failures occur on the soffit of the beam in a tensile manner. Figure 14b illustrates the typical compressive failure that was observed during the B series of tests. The post-tensioned, bonded, glulam timber specimens failed in a compressive manner, with the origin of the failure frequently occurring below the surface of the beam in accordance with the plastic stress profile previously discussed.

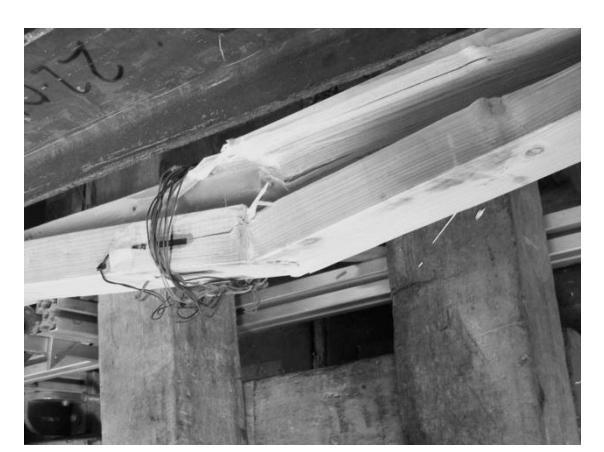
Fig. 14b Typical compressive/shear failure of post-tensioned glulam timber

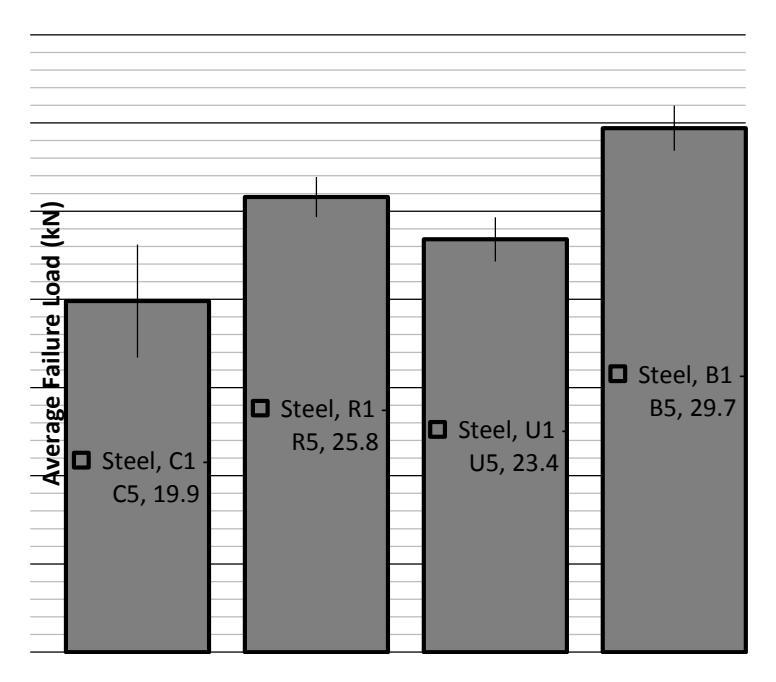
Fig. 15 Average flexural capacity with standard deviation error bars for all experimental testing

Table 6 and Figure 15 further highlight the difference between various test series conducted. Figure 15 represents the average flexural capacity of the various experimental series, with the inclusion of error bars representing the standard deviation of the members within the test. It is evident that post-tensioning positively affects the performance of the glulam timber, with a higher ultimate capacity and lower variation between the members on average.
