Published in:
Journal of Manufacturing Processes

Advances in the surface defect machining (SDM) of hard steels

Waleed Bin Rashid^a and Saurav Goel^{b*}

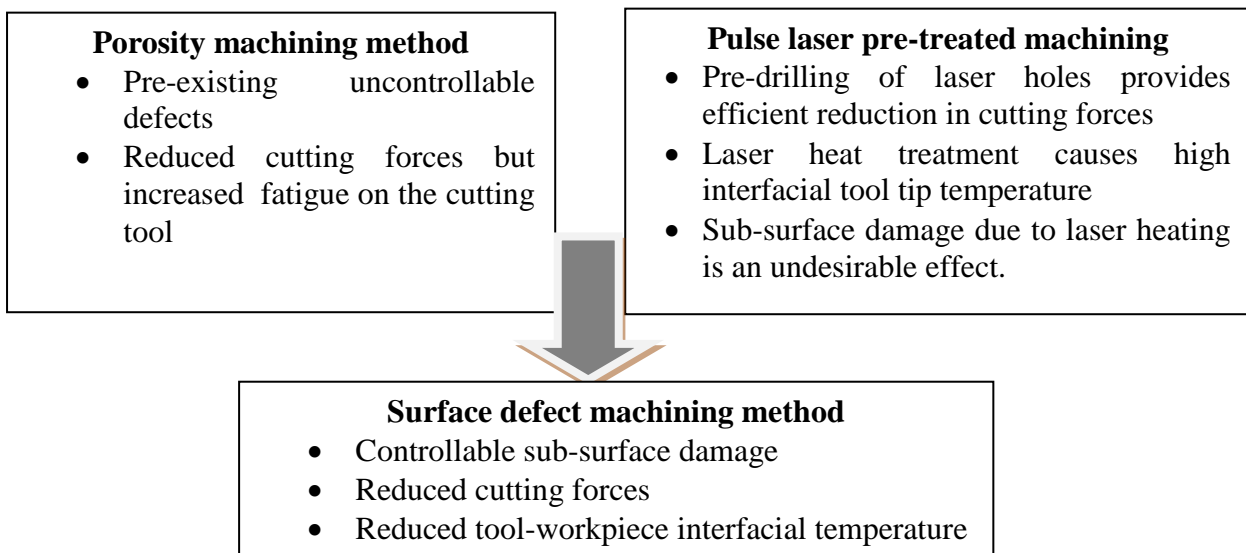
Figure 1: Development of the surface defect machining method [23]

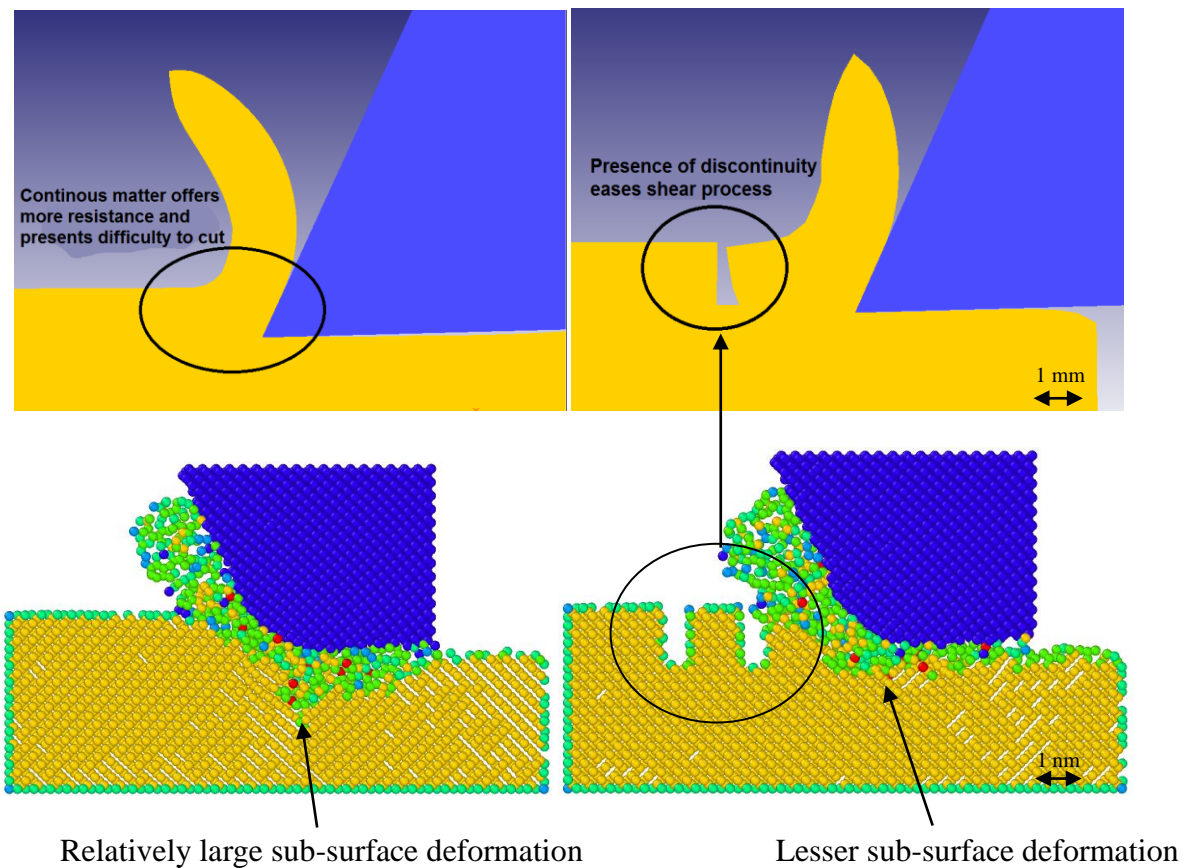
Figure 2: Schematic diagram indicating the differences between the mode of deformation during conventional machining and SDM observed through FEA simulation of hard steel and MD simulation of silicon carbide respectively.

The motivation for developing the SDM method originated from the hypothesis that changing the removal mechanism for cutting chips from continuous to discontinuous minimizes the problems caused by continuous cutting especially during HT. The cutting chips during HT can collide either with the machined surface or with the cutting tool which could damage the surface quality of the part being machined. Moreover, surface discontinuities break the energy barriers associated with the critical deformation load, i.e. the surface defects allow easy shearing of the material as shown schematically at two different scales in Figure 2. Therefore, SDM provides a product which has good surface integrity compared to that obtained using conventional hard turning. These advantages point to the fact that a component machined using the SDM method should exhibit improved quality of the machined surface; therefore, an experimental investigation to test this hypothesis was employed and is outlined in this paper.

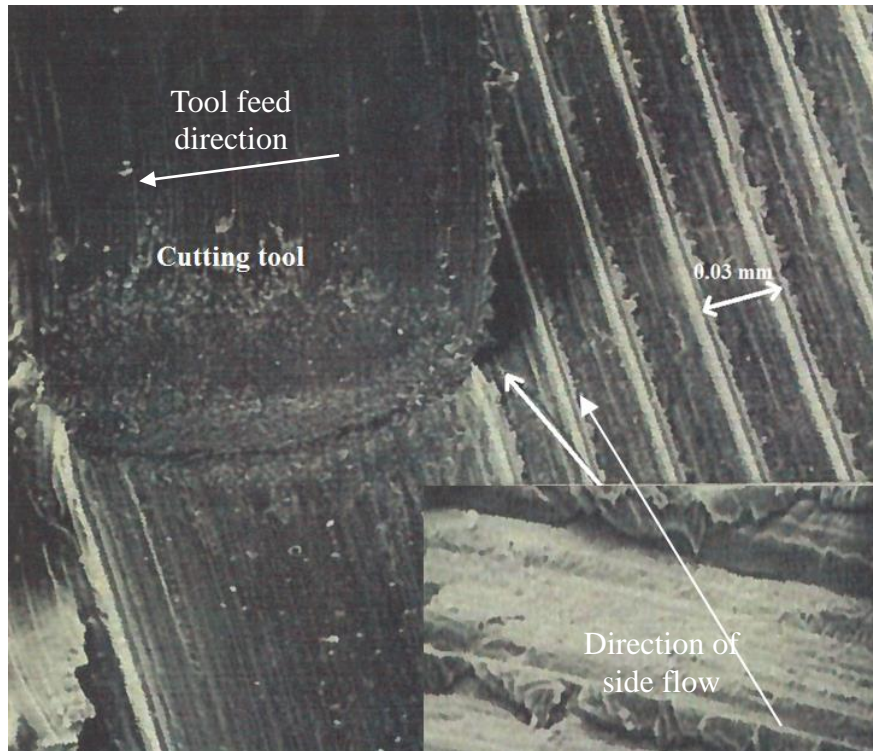
Figure 3: High speed camera image of the cutting zone showing a close up view of the machined surface – adapted [33].

In their pioneering work, Pekelharing and Gieszen [33] presented photographic evidence of the occurrence of the pile-up and side flow with the aid of a high speed imaging camera as shown in Figure 3. They demonstrated that the workpiece material displaced sideways by the cutting tool in any cutting operation is analogous to the observations found during a classical indentation process. As shown in Figure 3, the direction of the side flow on the machined surface appears to be opposite to the direction of the feed rate. This extra material is removed by the cutting tool during the course of machining, leading to abrasion, surface corrosion and micro-cracking [29]. Furthermore, the adhered material is hard, has a tendency to abrade and is therefore apt to wear the working surface to which it comes in contact with [28]. Liu *et al.* [27] and Sata *et al.* [36] have stated that, together, side flow and pile up are the most important types of surface deterioration and can influence surface roughness by up to 6 μm . Wardany *et al.* [29] indicated that side flow is heavily influenced by the cutting tool nose radius, feed motion and the progression of the tool wear resulting in an altered cutting tool profile. Other researchers [28, 36, 37] mentioned that cutting speed has a significant

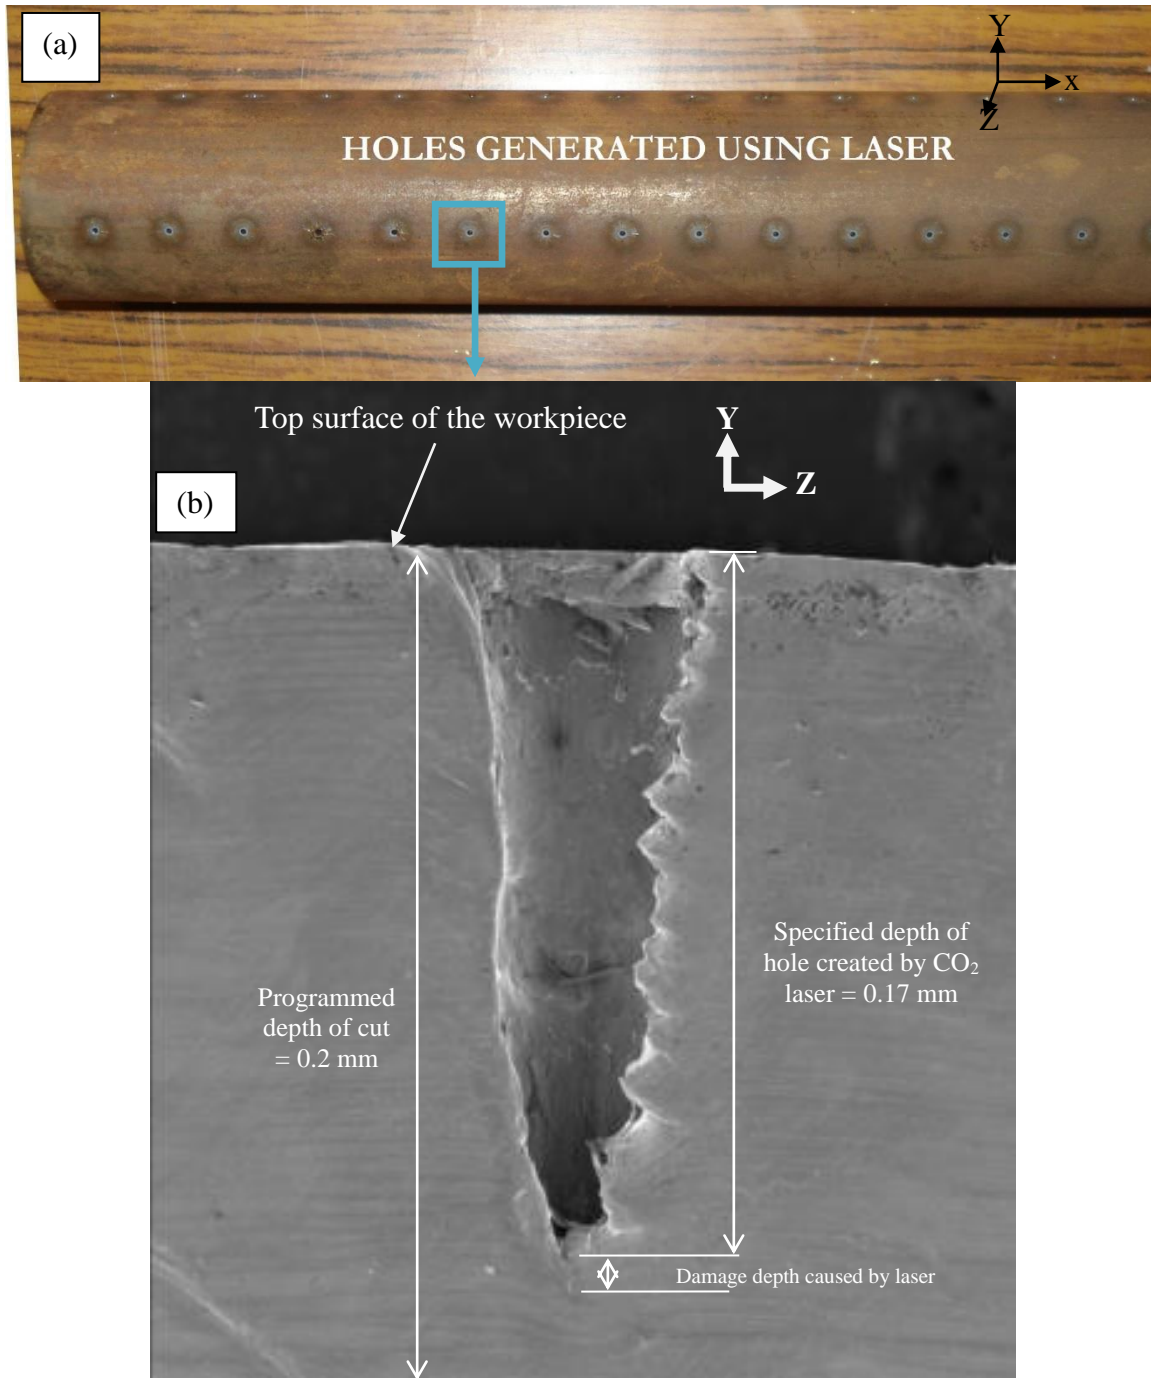
Figure 4: (a) Photographic image of the workpiece indicating manufactured surface defects created by the laser and (b) SEM image of the cross section of one of the surface defect created by CO₂ laser highlighting the damage depth caused by laser

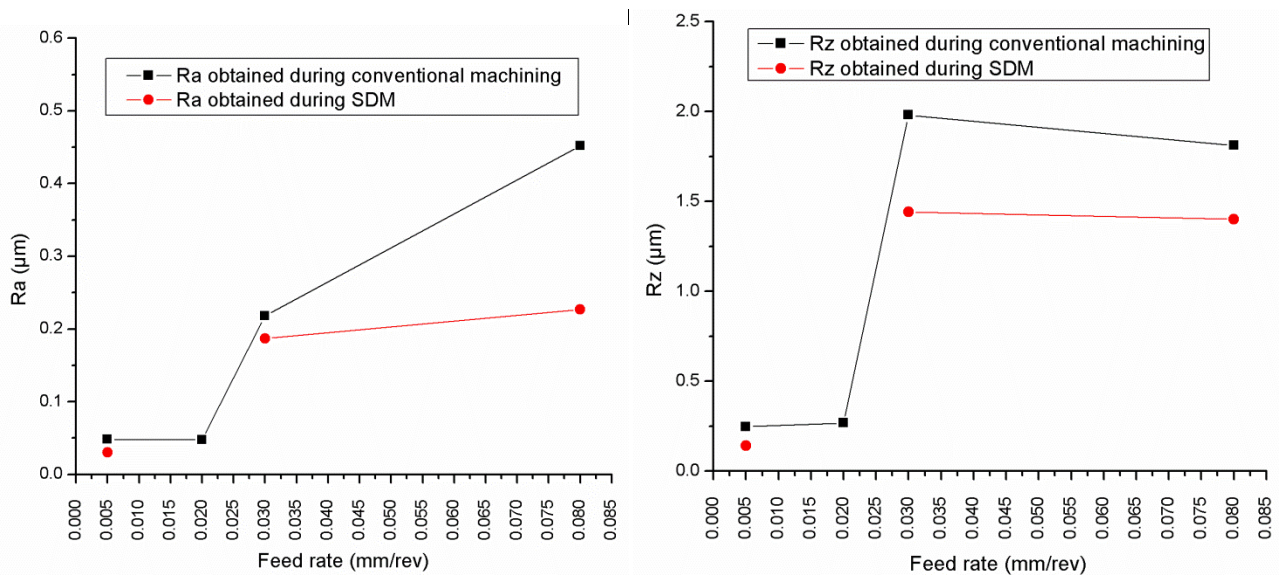
Figure 5 highlights the average variation in the measurement of the finish machined surface roughness, the average machined surface roughness (Ra) and peak to valley measurement (Rz).

Figure 5: Variation in Ra and Rz with respect to feed rate during conventional machining and SDM

The plot in the figure 5 shows that a feed rate of 0.02 mm/rev is critical for attaining the best possible machined surface roughness using conventional hard turning method, indeed lowering of this value further to 0.005 mm/rev produced the same result i.e. Ra of 0.0478 μm . Compared to this value, the SDM method was able to provide a much better surface roughness of about Ra 30 nm which corresponds to the Form Talysurf measurement shown in Figure 6. This demonstrates that the critical feed barrier can be overcome by adopting the SDM method to obtain a better machined surface roughness. It means that SDM could potentially enable the accomplishment of a precision finish equivalent to that obtained by polishing and grinding process using conventional turning. Indeed, contrary to the earlier limitations reported by Konig *et al.* [45] where geometric tolerances corresponding to IT6 and the surface qualities of Rtm 2-3 μm are the maximum attainable, this research shows for the first time that IT4 is now achievable through state-of-the-art HT processing [1] using SDM. Of particular importance in this regard is the fact that the ASTM standard recommends the surface roughness value (Ra) on the metallic knee joint implants to be lower than 100 nm [46]; this was obtained with ease during this study. Furthermore, although ceramics such as silicon carbide are preferred choice over steels [47, 48] for such advanced biomedical applications, stainless steel is still used in practice and this work demonstrates that there is the potential to use hard turning to machine such precise components.

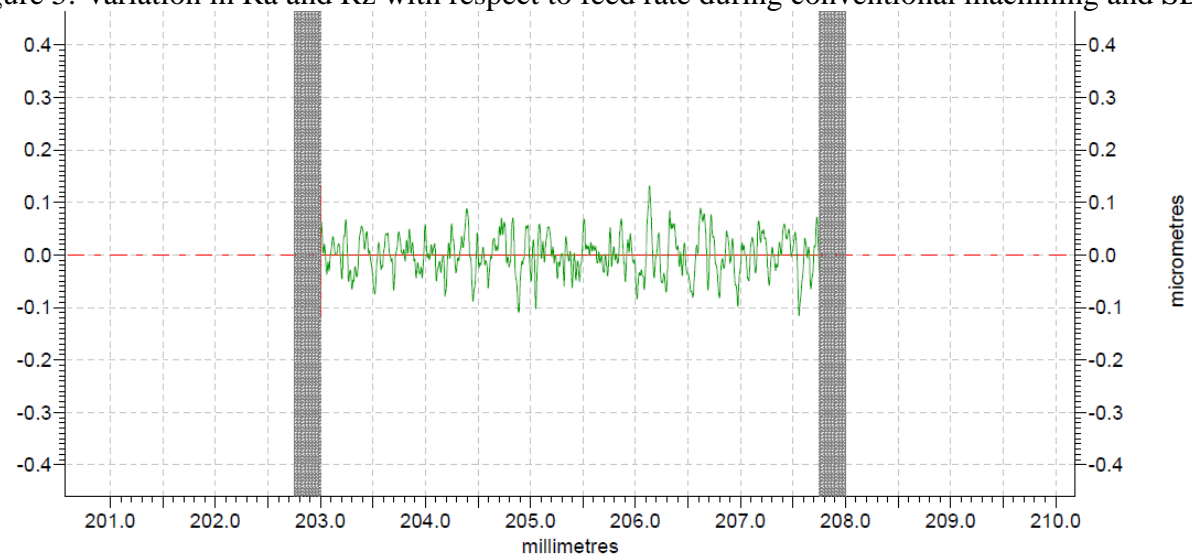
Slope	0.479	°		
Ra	0.0300	µm			
	-0.0469				
	Rt	0.2469	µm		
	Rz	0.1415	µm

Figure 6: The average value of machined surface roughness of Ra 30 nm obtained on an AISI 4340 steel specimen machined using SDM

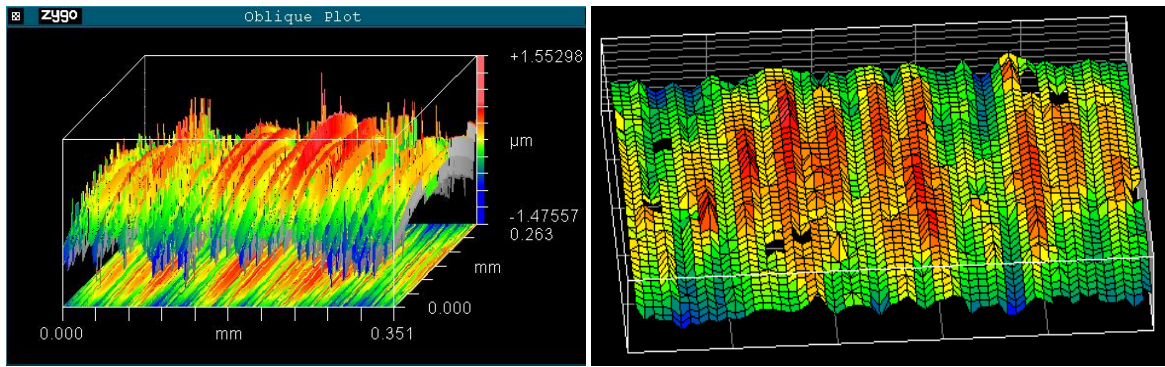
Figure 7: Topography of the machined surface obtained using SDM

In order to gain even further insights into the process, the surface topographies of the machined surfaces obtained via classic HT (conventional machining only) and the SDM method were carefully studied. Figures 7 and 8 show this comparison for the final finished surface obtained in the two tests at a feed rate of 0.03 mm/rev. From this comparison, the P-V values obtained by the SDM method appeared much better than that obtained from classic HT.

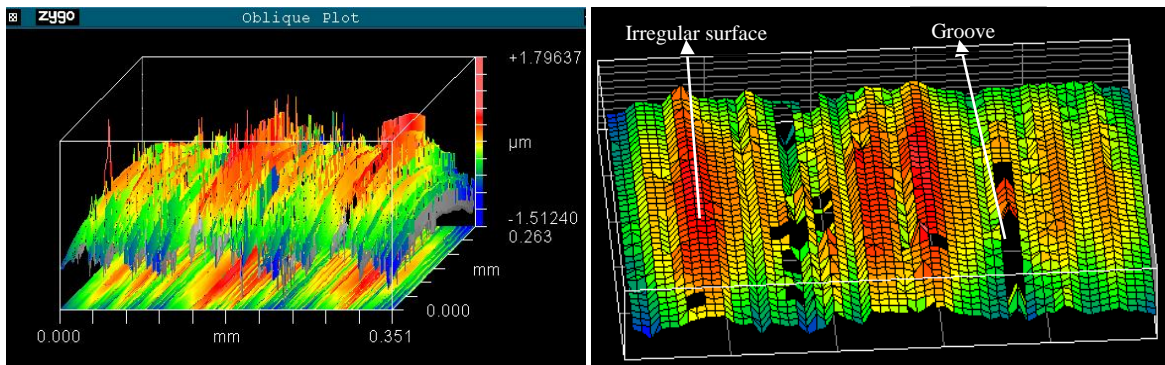
Figure 8: Topography of the machined surface obtained using classical HT

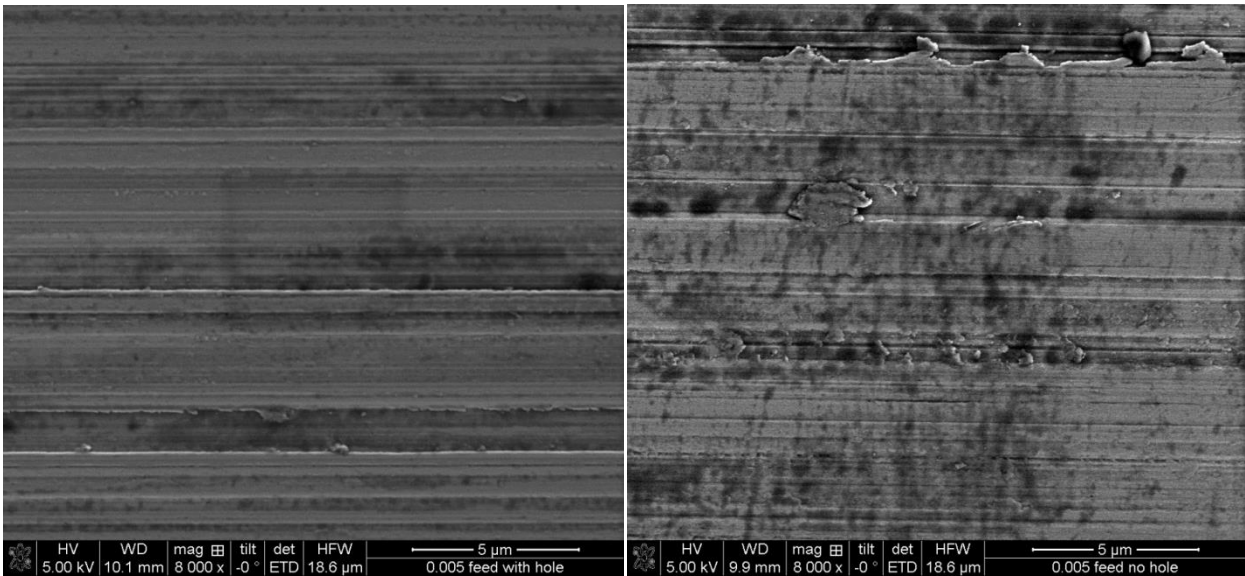
Figure 9: A comparison of the surface topography obtained via SEM under two different machining conditions: (a) surface defect machining method and (b) classical hard turning

Other than the quantitative improvement in the surface roughness, a key difference observed was the presence of grooves, ridges and irregularities in the surface obtained via conventional HT whereas using SDM, a more uniform machined surface was obtained with minimum variation in the machined surface profile. This was further confirmed by carefully assessing the machined surface using SEM imaging shown in Figure 9 where the extent of pile-up and the occurrence of side flow during the SDM process were observed to be considerably reduced when compared to the classical HT approach, resulting in a better quality of machined surface roughness.

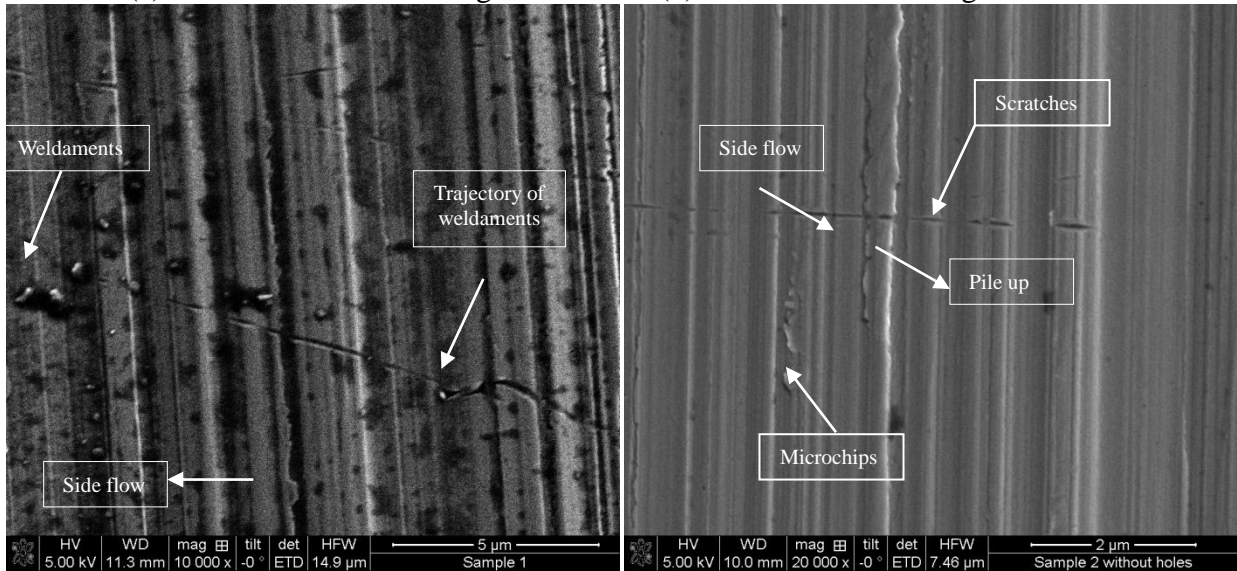
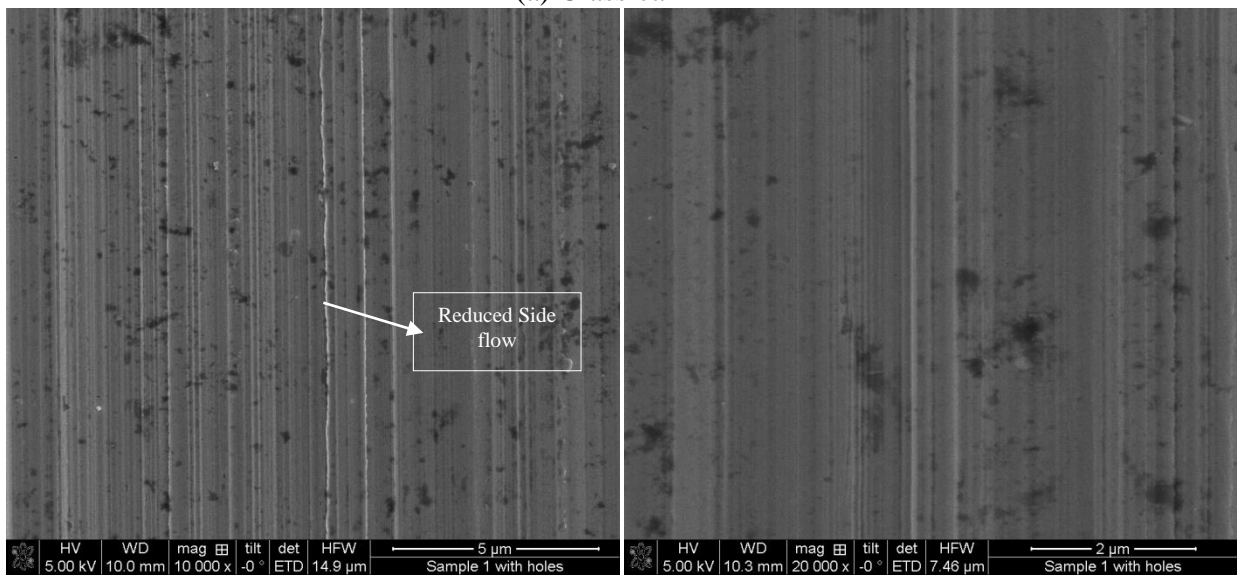
(a) Classical HT

(b) SDM method

Figure 10: SEM examination of the machined surface qualities obtained from SDM

Figure 10 presents a comparison of the SEM images of the machined surface under the two machining conditions obtained from conventional HT and the SDM induced HT method. A significant difference between the qualities of the two machined surfaces is evident. Figure 10a reveals the appearance of several kinds of surface defects, e.g. excessive side flow, the presence of microchips on the machine surface, the presence of weldment particles and penetration of these particles in the machined surface forming scratches on the machined surface. As seen from the existing literature and this study, the post experimental SEM inspection of the machined surfaces obtained after conventional HT shows the appearance of all such surface defects which are precursor to the shortened service life of machined components. Contrary to this, the machined surface obtained from the SDM method showed a negligible extent of side flow and no considerable appearance of microchips on the finished surface. Another improvement observed from SDM was a reduction in the amount and appearance of the weldment particles. As discussed previously, small fractured edges of the steel subjected to an extremely high machining temperature in the cutting zone promote conditions for welding. The surface machined with SDM was found to be free from such weldments which in itself is an outcome of the reduced machining temperature during this SDM process [19].

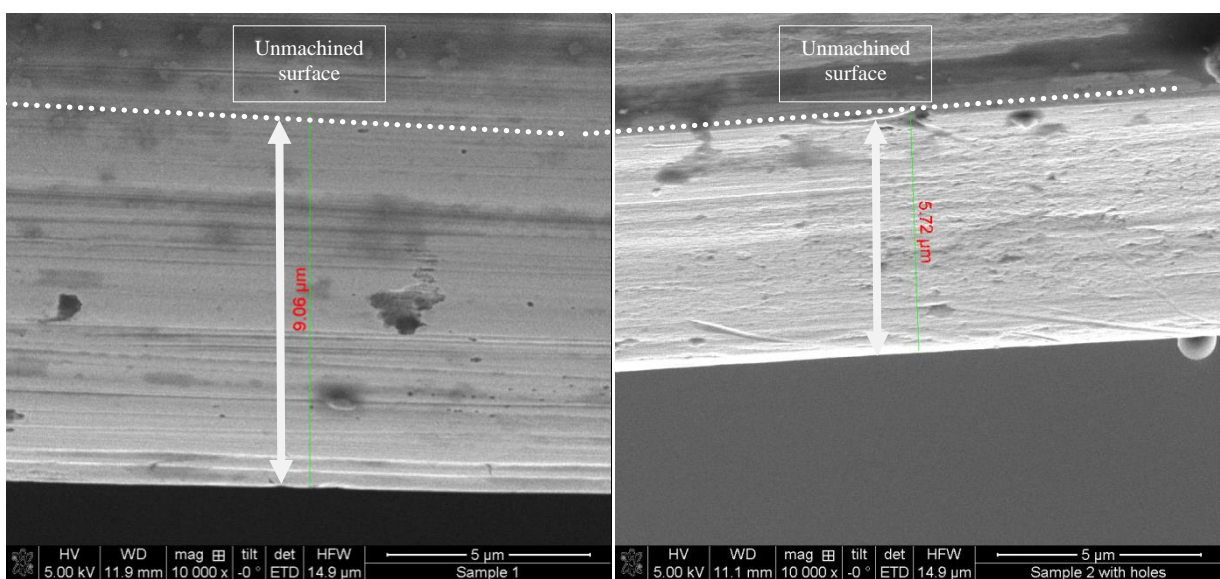
Figure 11: Measurement of white layer on the finished machined surface (a) Conventional HT (b) SDM induced HT

The formation and presence of white layer generated during classical hard turning has always been a limiting factor in the adoption of hard turning on the shop floor. It was therefore necessary to investigate whether or not the extent of white layer was affected by the use of SDM therefore SEM imaging was employed in accord with the traditional procedure [49]. Figure 11 compares the extent of white layer formation under the two test cases. The extent of the white layer measured in the classical HT specimen was $9.06\ \mu\text{m}$; this was substantially reduced to only $5.72\ \mu\text{m}$ in the SDM specimen signifying that SDM could reduce the metallurgical transformation on the surface during the machining process.

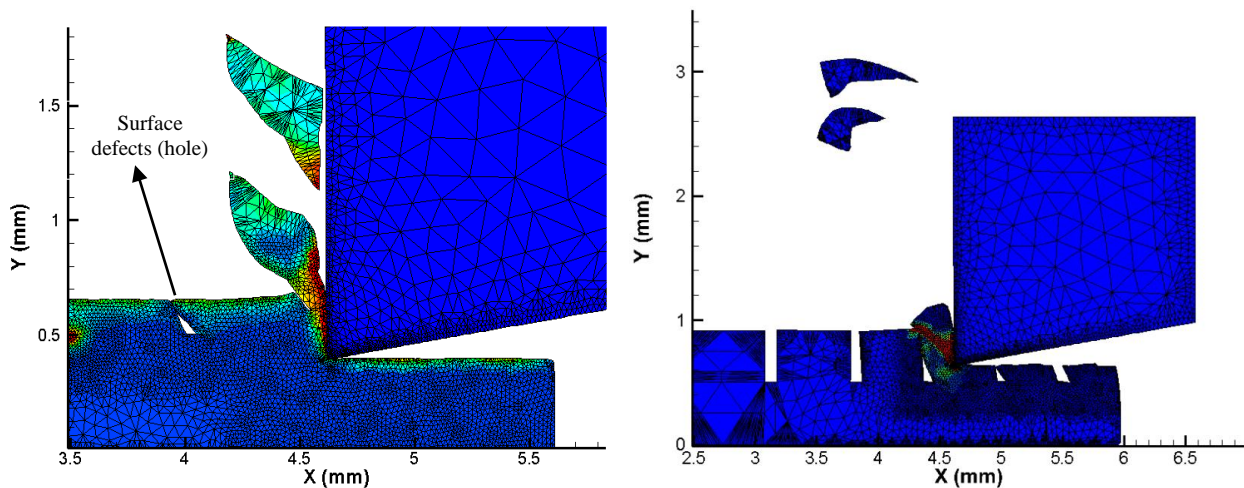
Figure 12: Finite element analysis of the surface defect machining of hard steel when the: (a) depth of surface defects is less than the depth of cut and (b) depth of surface defects is larger than the depth of cut

To further support the above experimental findings, an FEA was carried out to simulate the surface defect machining of AISI 4340 steel. These FEA simulations are in continuation of previously performed simulations, therefore the details of these are not repeated here for the purposes of brevity [23]. The results are shown for two cases where: (i) the depth of surface defects is less than the depth of cut and (ii) the depth of surface defect is more than the depth of cut. This enabled a more complete understanding of the whole process. The results in Figure 12 show the plastic strain during the machining. The most remarkable observation obtained from the FEA of SDM was a significant reduction in the shear plane angle due to a reduction in shear plane area during

machining. A decrease in the value of shear plane angle under the same machining parameters indicates the dominance of tangential cutting forces over thrust forces, which shows an enhanced cutting action of the tool. This means that for the same amount of energy input, the cutting action is considerably enhanced and the forces in the direction of the cutting velocity vector increases. Consequently, the deformation of the material occurs along the cutting direction and causes less side flow resulting in the improved machined quality of surface.
