Advances in the surface defect machining (SDM) of hard steels

Rashid, W. B., & Goel, S. (2016). Advances in the surface defect machining (SDM) of hard steels. *Journal of Manufacturing Processes*, 23, 37-46. <https://doi.org/10.1016/j.jmapro.2016.05.007>

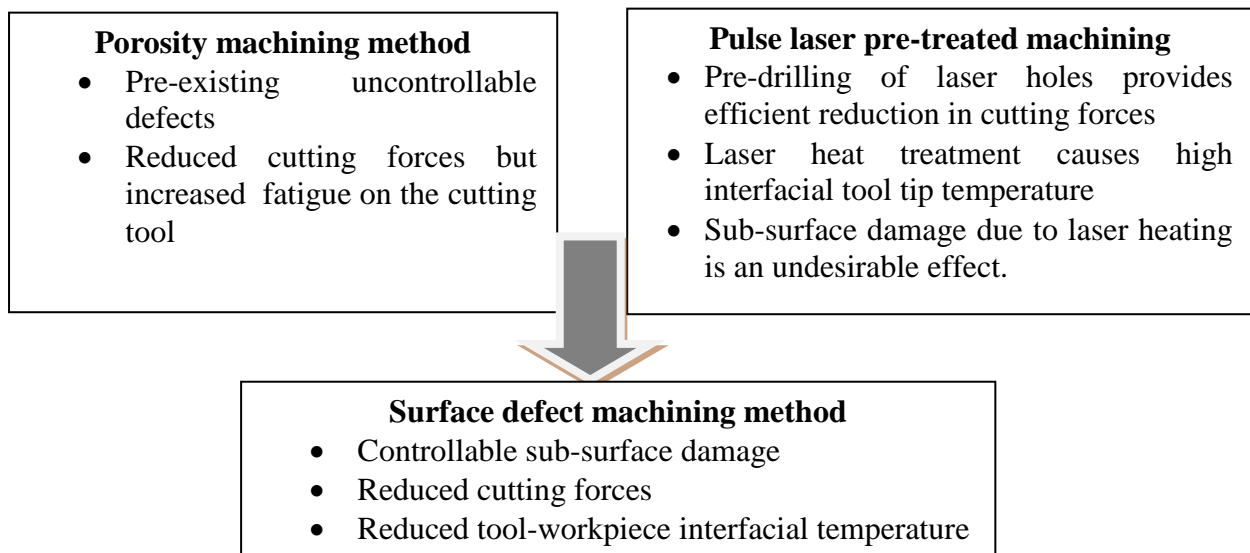
Figure 1: Development of the surface defect machining method [23]

demonstrating HT as a viable solution which can improve surface finish and surface integrity. SDM is a relatively new approach which was primarily developed to machine hard ferrous alloys [19] at macroscale but has been shown theoretically to be applicable down to the nanoscale for machining brittle materials such as silicon carbide [20]. It has been demonstrated that SDM harnesses the combined advantages of both porosity machining [21] and pulse laser pre-treatment [22] as shown in Figure 1 by machining a workpiece by initially generating surface defects at depths less than the uncut chip thickness through either mechanical means and/or thermal means followed by a routine conventional machining operation.

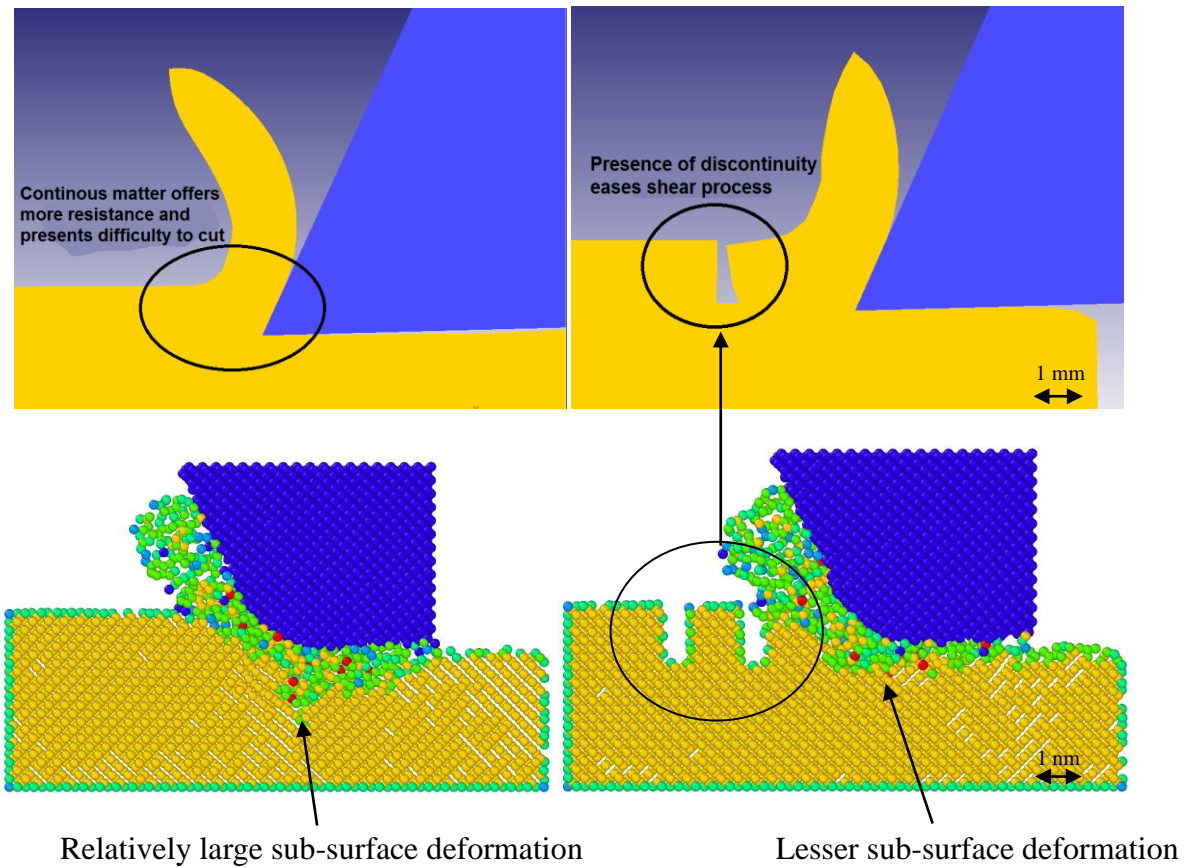
Figure 2: Schematic diagram indicating the differences between the mode of deformation during conventional machining and SDM observed through FEA simulation of hard steel and MD simulation of silicon carbide respectively.

State-of-the-art modelling and simulation methods [23] have been used to discover a number of promising features of the SDM approach including lower machining forces, reductions in overall temperature in the cutting zone, reduced machining stresses and increased chip flow velocity. An interesting observation during these studies was that the SDM mechanism alters the chip morphology from jagged to discontinuous. This ties in with the fact that SDM enables ease of deformation by shearing the material at reduced input energy [23]. Also, due to the large proportion of stress concentration in the cutting zone - rather than the sub-surface – it enables a reduction in the associated residual stresses on the machined surface.

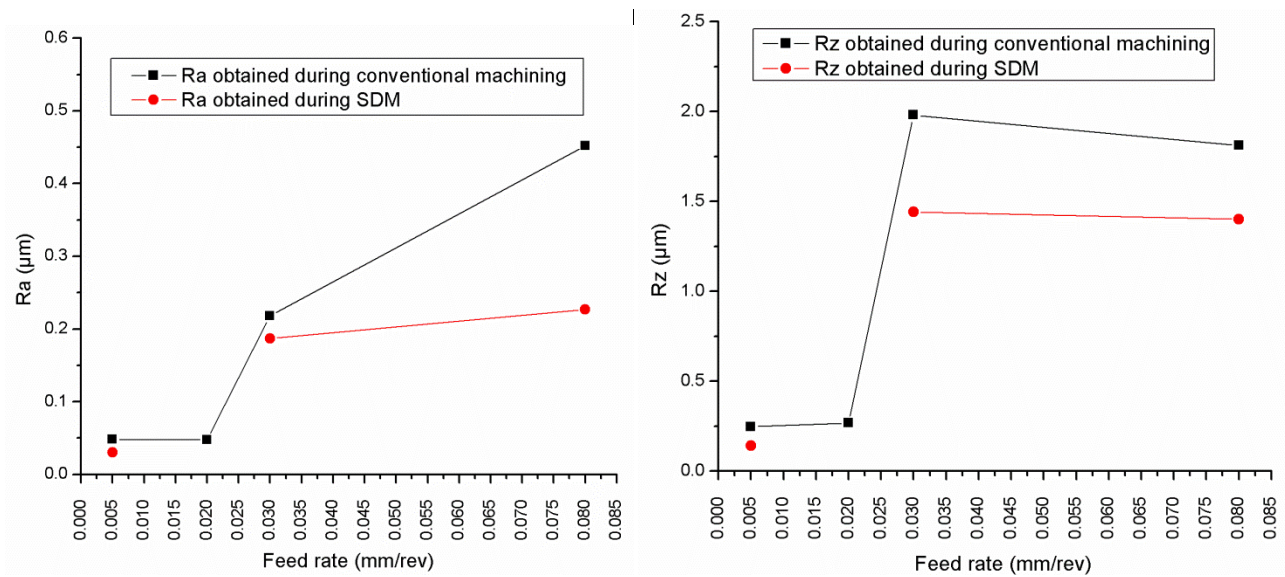
Figure 5 highlights the average variation in the measurement of the finish machined surface roughness, the average machined surface roughness (Ra) and peak to valley measurement (Rz).

Figure 5: Variation in Ra and Rz with respect to feed rate during conventional machining and SDM

The plot in the figure 5 shows that a feed rate of 0.02 mm/rev is critical for attaining the best possible machined surface roughness using conventional hard turning method, indeed lowering of this value further to 0.005 mm/rev produced the same result i.e. Ra of 0.0478 μm . Compared to this value, the SDM method was able to provide a much better surface roughness of about Ra 30 nm which corresponds to the Form Talysurf measurement shown in Figure 6. This demonstrates that the critical feed barrier can be overcome by adopting the SDM method to obtain a better machined surface roughness. It means that SDM could potentially enable the accomplishment of a precision finish equivalent to that obtained by polishing and grinding process using conventional turning. Indeed, contrary to the earlier limitations reported by Konig *et al.* [45] where geometric tolerances corresponding to IT6 and the surface qualities of Rtm 2-3 μm are the maximum attainable, this research shows for the first time that IT4 is now achievable through state-of-the-art HT processing [1] using SDM. Of particular importance in this regard is the fact that the ASTM standard recommends the surface roughness value (Ra) on the metallic knee joint implants to be lower than 100 nm [46]; this was obtained with ease during this study. Furthermore, although ceramics such as silicon carbide are preferred choice over steels [47, 48] for such advanced biomedical applications, stainless steel is still used in practice and this work demonstrates that there is the potential to use hard turning to machine such precise components.

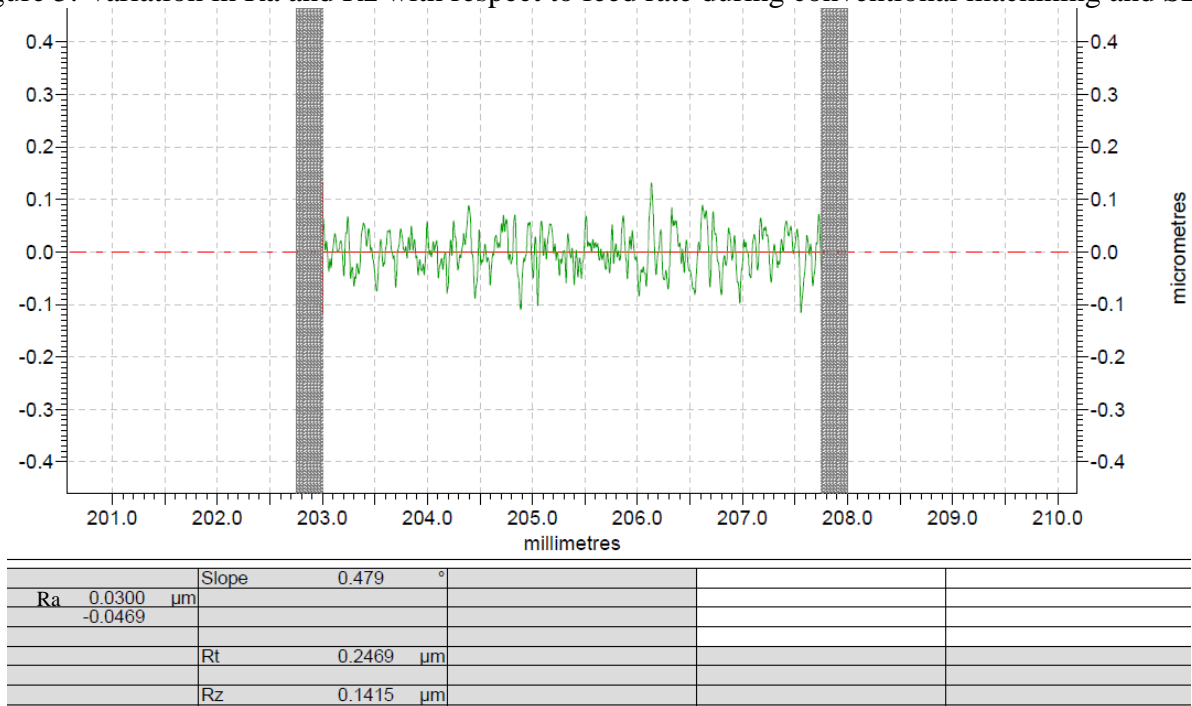
Figure 6: The average value of machined surface roughness of Ra 30 nm obtained on an AISI 4340 steel specimen machined using SDM

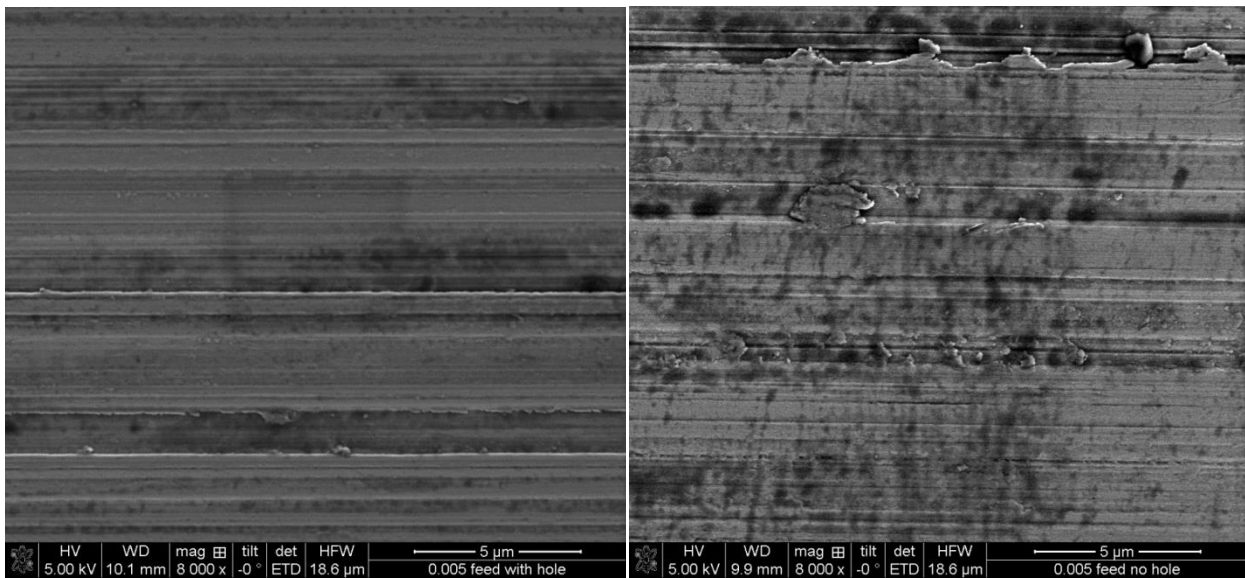
Figure 9: A comparison of the surface topography obtained via SEM under two different machining conditions: (a) surface defect machining method and (b) classical hard turning

Other than the quantitative improvement in the surface roughness, a key difference observed was the presence of grooves, ridges and irregularities in the surface obtained via conventional HT whereas using SDM, a more uniform machined surface was obtained with minimum variation in the machined surface profile. This was further confirmed by carefully assessing the machined surface using SEM imaging shown in Figure 9 where the extent of pile-up and the occurrence of side flow during the SDM process were observed to be considerably reduced when compared to the classical HT approach, resulting in a better quality of machined surface roughness.

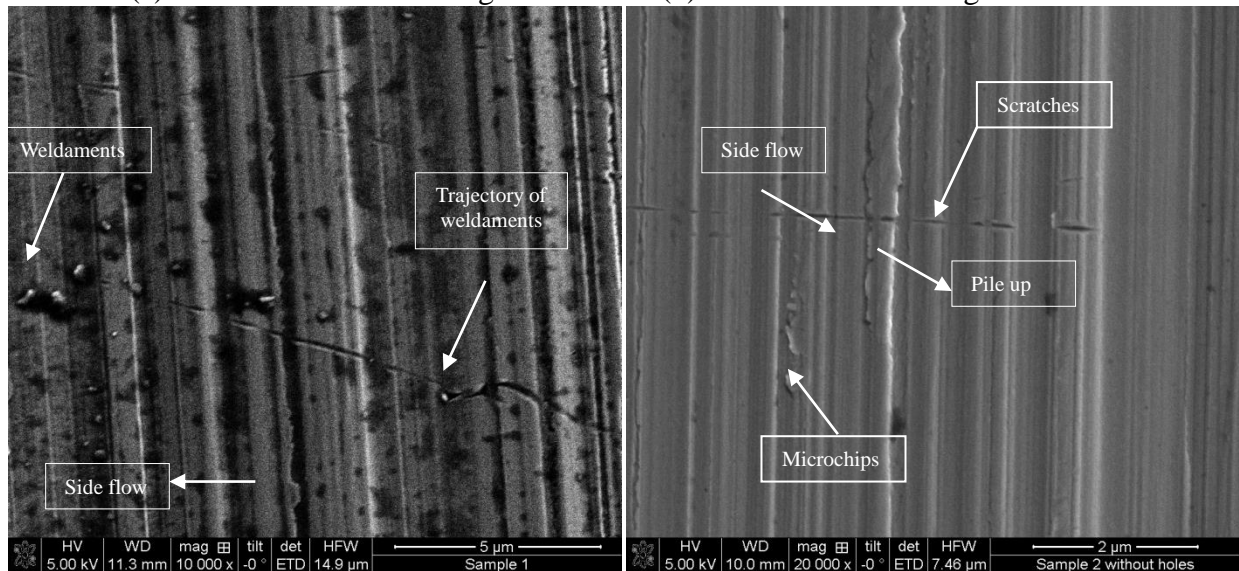
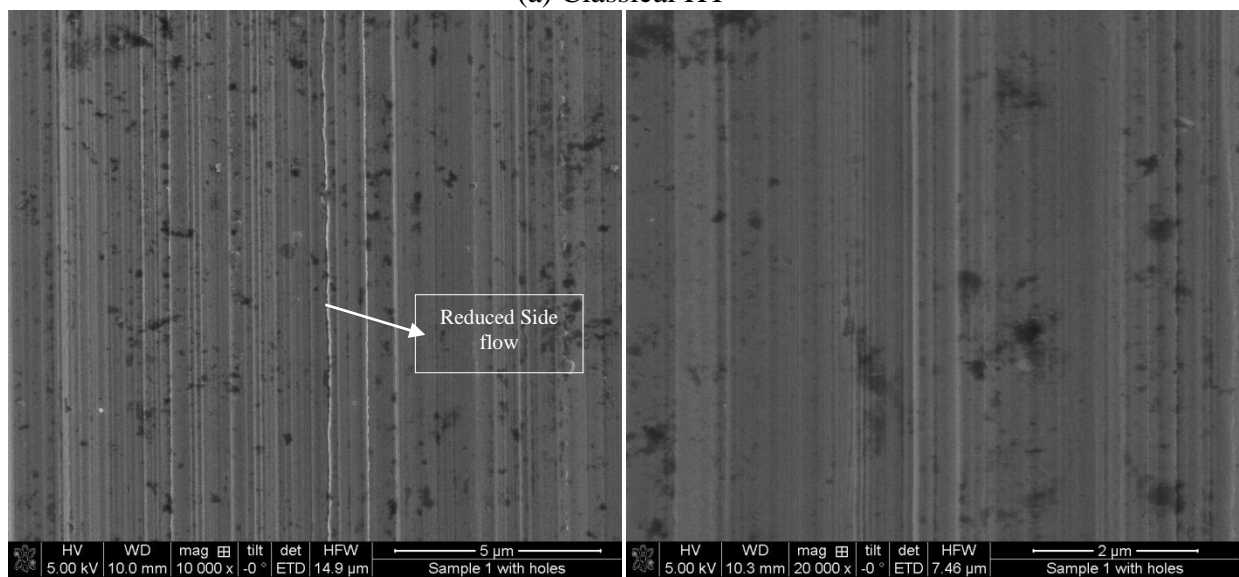
(a) Classical HT

(b) SDM method

Figure 10: SEM examination of the machined surface qualities obtained from SDM

Figure 10 presents a comparison of the SEM images of the machined surface under the two machining conditions obtained from conventional HT and the SDM induced HT method. A significant difference between the qualities of the two machined surfaces is evident. Figure 10a reveals the appearance of several kinds of surface defects, e.g. excessive side flow, the presence of microchips on the machine surface, the presence of weldment particles and penetration of these particles in the machined surface forming scratches on the machined surface. As seen from the existing literature and this study, the post experimental SEM inspection of the machined surfaces obtained after conventional HT shows the appearance of all such surface defects which are precursor to the shortened service life of machined components. Contrary to this, the machined surface obtained from the SDM method showed a negligible extent of side flow and no considerable appearance of microchips on the finished surface. Another improvement observed from SDM was a reduction in the amount and appearance of the weldment particles. As discussed previously, small fractured edges of the steel subjected to an extremely high machining temperature in the cutting zone promote conditions for welding. The surface machined with SDM was found to be free from such weldments which in itself is an outcome of the reduced machining temperature during this SDM process [19].

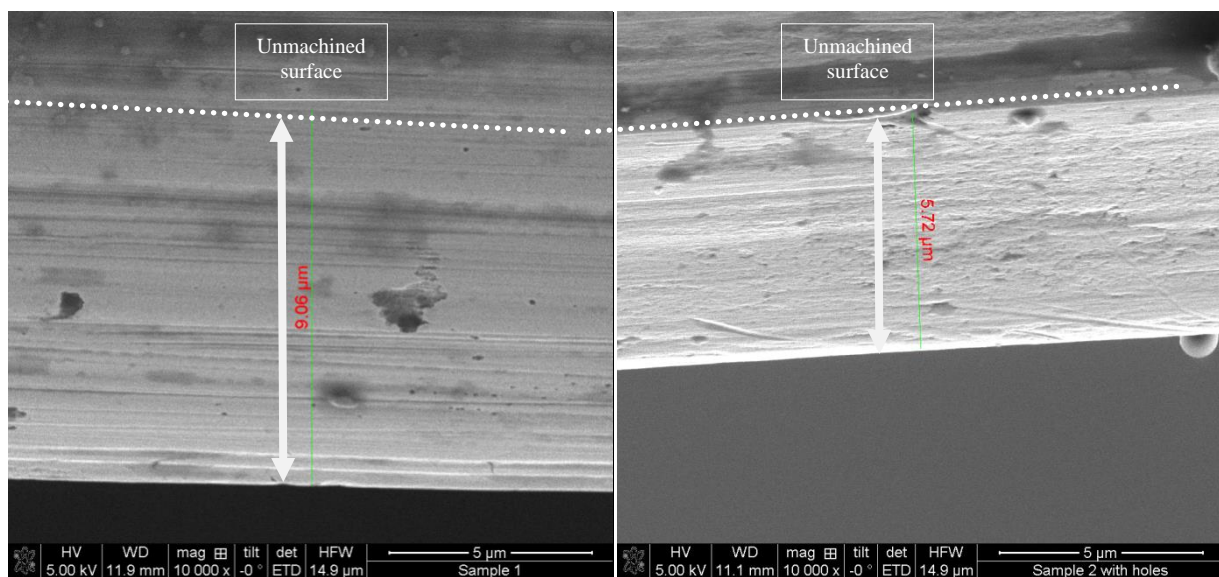
Figure 11: Measurement of white layer on the finished machined surface (a) Conventional HT (b) SDM induced HT

The formation and presence of white layer generated during classical hard turning has always been a limiting factor in the adoption of hard turning on the shop floor. It was therefore necessary to investigate whether or not the extent of white layer was affected by the use of SDM therefore SEM imaging was employed in accord with the traditional procedure [49]. Figure 11 compares the extent of white layer formation under the two test cases. The extent of the white layer measured in the classical HT specimen was $9.06\text{ }\mu\text{m}$; this was substantially reduced to only $5.72\text{ }\mu\text{m}$ in the SDM specimen signifying that SDM could reduce the metallurgical transformation on the surface during the machining process.

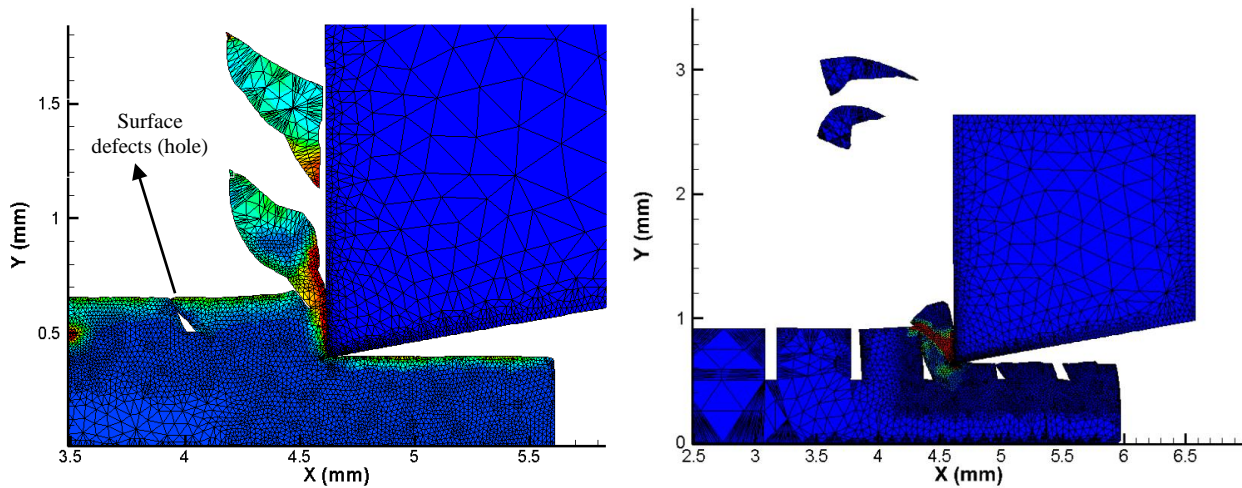
Figure 12: Finite element analysis of the surface defect machining of hard steel when the: (a) depth of surface defects is less than the depth of cut and (b) depth of surface defects is larger than the depth of cut

To further support the above experimental findings, an FEA was carried out to simulate the surface defect machining of AISI 4340 steel. These FEA simulations are in continuation of previously performed simulations, therefore the details of these are not repeated here for the purposes of brevity [23]. The results are shown for two cases where: (i) the depth of surface defects is less than the depth of cut and (ii) the depth of surface defect is more than the depth of cut. This enabled a more complete understanding of the whole process. The results in Figure 12 show the plastic strain during the machining. The most remarkable observation obtained from the FEA of SDM was a significant reduction in the shear plane angle due to a reduction in shear plane area during

machining. A decrease in the value of shear plane angle under the same machining parameters indicates the dominance of tangential cutting forces over thrust forces, which shows an enhanced cutting action of the tool. This means that for the same amount of energy input, the cutting action is considerably enhanced and the forces in the direction of the cutting velocity vector increases. Consequently, the deformation of the material occurs along the cutting direction and causes less side flow resulting in the improved machined quality of surface.
