Li, N., Wang, N., Sha, M., Sha, W., & Zhang, J. (2015). Oxidation-induced Cu coating on steel surface. *Materials Science Forum*, 817, 71-75. <https://doi.org/10.4028/www.scientific.net/MSF.817.71>

Oxidation-induced Cu Coating on Steel Surface

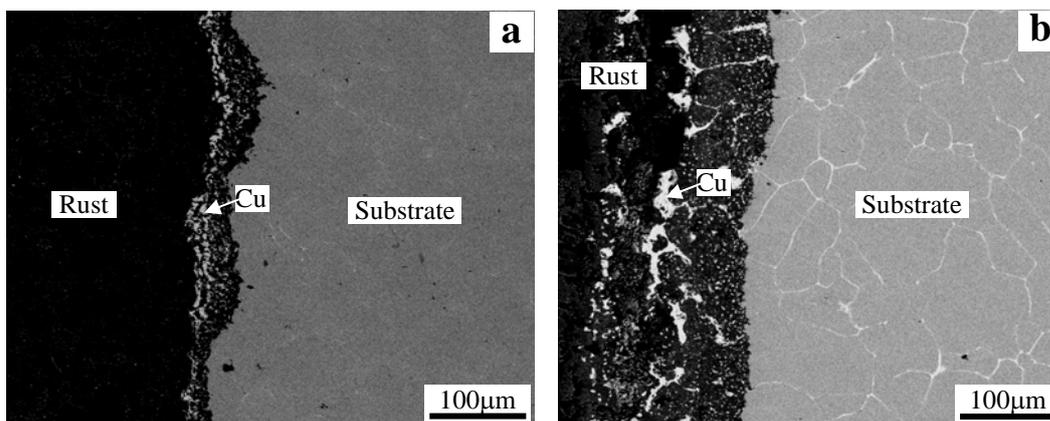
Thick rusts appeared on all the samples after being heated at high temperature, 1000°C and 1150°C in current work. Fig.1 shows the back scattered electron images of the inclined cross section of the test steels heated at 1000°C for 2h. Oxidation of iron happened rapidly during heating process, and the oxides appear in black in Fig.1. On the other hand, the oxidation of copper at these temperatures was slow comparing with iron. Both samples show that separately scattered copper particles, the brighter parts in back scattered electron images in Fig.1 with more than 95% copper according to EDX results, distributed near the substrate in the rusts. The copper in the rusts have little or nothing to do with the development of the oxidation. In other words, the rusts connect directly to the substrate and it can be deduced that if the sample heating continued, the rust would keep growing.

Fig.1 Back scattered electron images of the inclined cross sections of the steel samples with 6.8%Cu (a) and 12.6%Cu (b) after heating at 1000°C for 2h.

For the steels with 6.8% copper (Fig.1a), the copper particles in the rust are much finer than those in the steels with 12.6% copper (Fig.1b). For the latter, in the substrate, a copper-rich phase precipitated at the grain boundaries because of the rather high copper content. At the same time, it is likely that a certain amount of copper dissolved in the steel as solid solution uniformly, and no copper-rich precipitation appeared in the steel with 6.8% copper as shown in Fig.1a. Under the temperature of 1000°C, the copper particles in the rusts cannot connect with each other even though the copper content is high enough to form copper-rich phases.

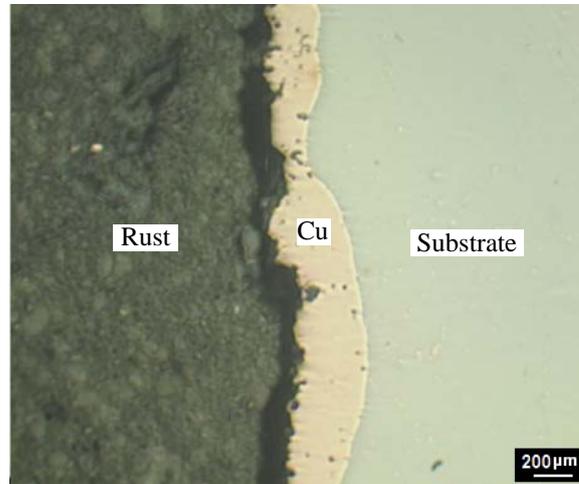
After heating at 1150°C, both steels show an integrated copper layer beneath the thick rusts. Fig.2 shows the morphology of the inclined cross section of steel with 6.8% copper after heating at 1150°C for 2h. The copper layer appears between rust and substrate, which was the perfect position of copper coating.

Fig.2 Optical microscope image of the inclined cross section of steel with 6.8%Cu after heating at 1150°C for 2h.

The thickness of copper coating changes from a few microns to tens of microns with some small oxide particles scattered in the layer. Major oxides were pushed away from the substrate and gathered at the outer layer as shown in Fig.2, and there were no copper particles scattered in the rusts either.

In Fig.2 and Fig.3, there is not any hole in the copper layer of the samples before descaling, so the holes in Fig.4 must be formed during the descaling process. From both Fig.2 and Fig.3, it can be observed that there are some dark particles with different sizes within the copper layer area, and they may have the same composition as spectrum 3 in Fig.3. In other words, there are some oxide particles in the copper, which were formed during heating and oxidation. These small oxide particles near the surface reacted with the descaling reagent and were dissolved in the solution, leaving small holes behind; then the solution reacted with other small oxide particles near these holes. These holes might become deeper or larger after the reaction, thus forming many holes with different depths and shapes. Therefore, further research should aim at achieving a clean surface without holes.

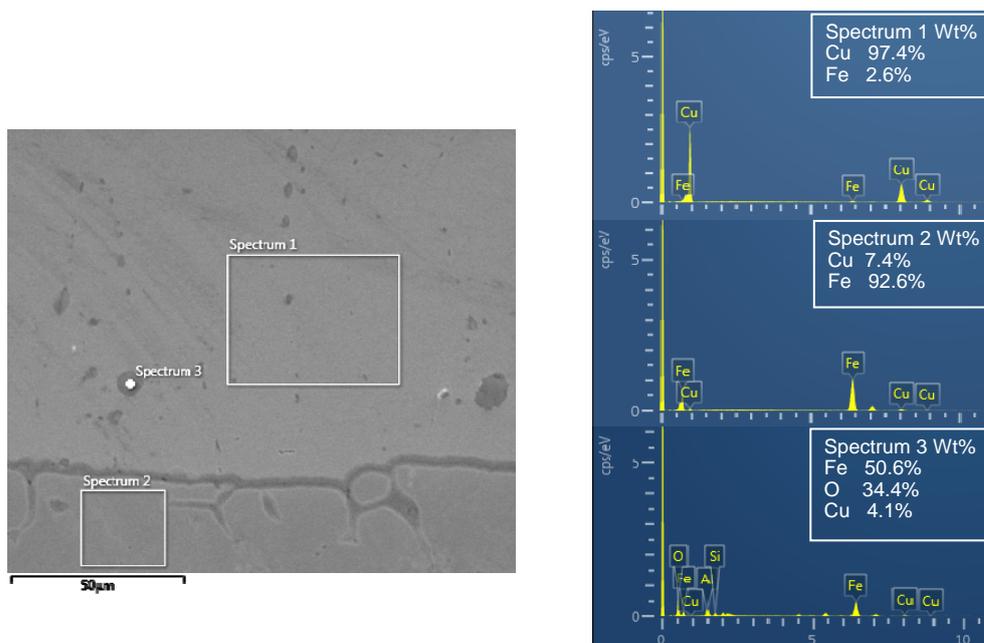
By observing the interface between the copper layer and substrate, as shown in Fig.3, a fine line can be seen at the interface. The brighter part above the line in Fig.3 is copper layer with copper content of higher than 97% according to EDX results, and the less bright part under the line is substrate with the copper content of 7.4%, close to the copper content of the bulk steel. The dark particles in the copper layer are mainly oxides of iron with small amount of copper. The copper coating and substrate connected perfectly and there is not any slight void between them, which usually can be seen in other composite materials, even though the interface is not so straight.

Fig.3 SEM morphology and EDX spectra of the substrate and Cu layer on the inclined cross section of steel with 6.8%Cu after heating at 1150°C for 2h.

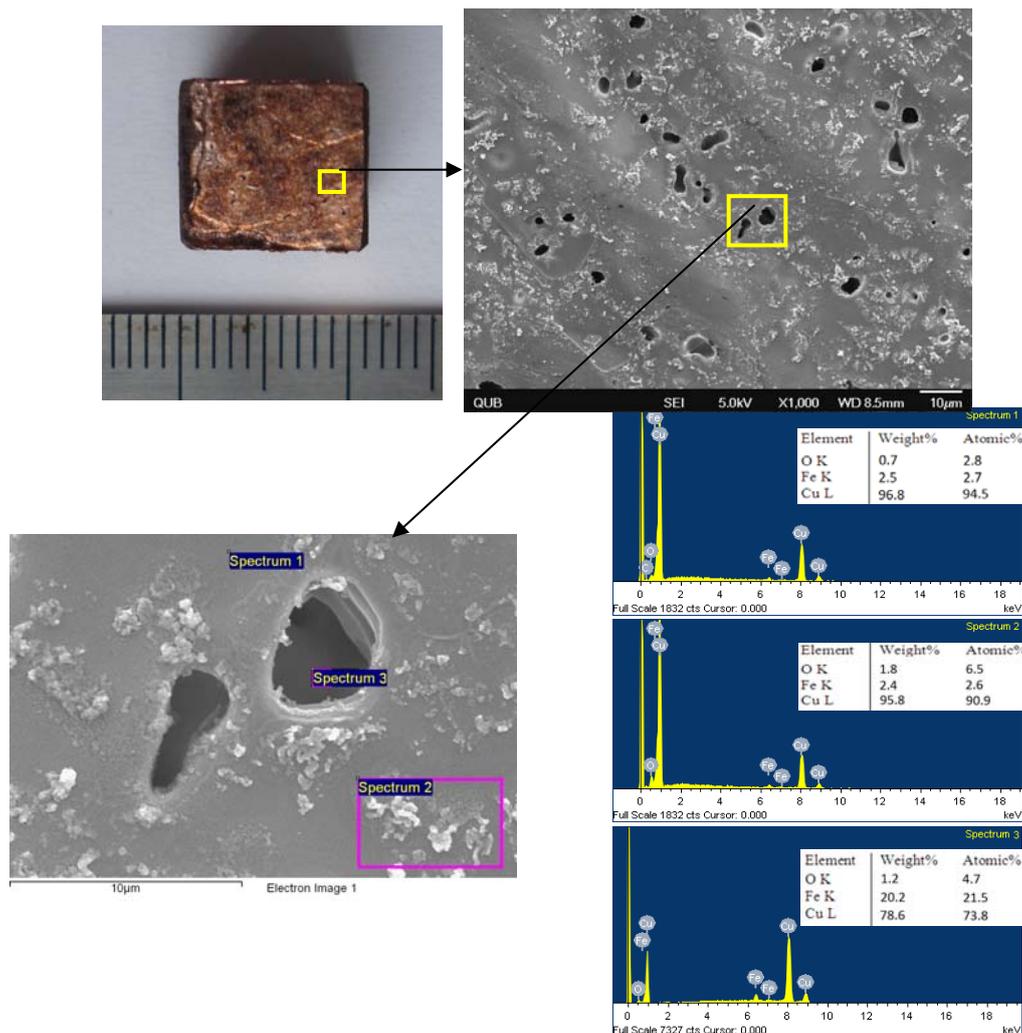
By choosing a proper descaling reagent, the rusts could be removed while keeping the copper layers, which can be judged by naked eyes because of copper's noble colour. The microstructure of the "copper coating" after descaling was observed with SEM, as shown in Fig.4. It shows that some irregular holes appeared on sample's surface after descaling. There are some oxide patches left on the surface as well, which are shown in white. Under the hole, EDX test result shows that the copper content decreased and the iron content increased correspondingly, though this analysis result is subjected to error, as EDX composition calculation is accurate only for flat surfaces.

Fig.4 Macro-photograph, SEM morphology and EDX spectra of the surface of the steel with 12.6%Cu after descaling.
